MSi Investigative Summary

SEM/EDS analysis of residue on encoder photodiode chip.

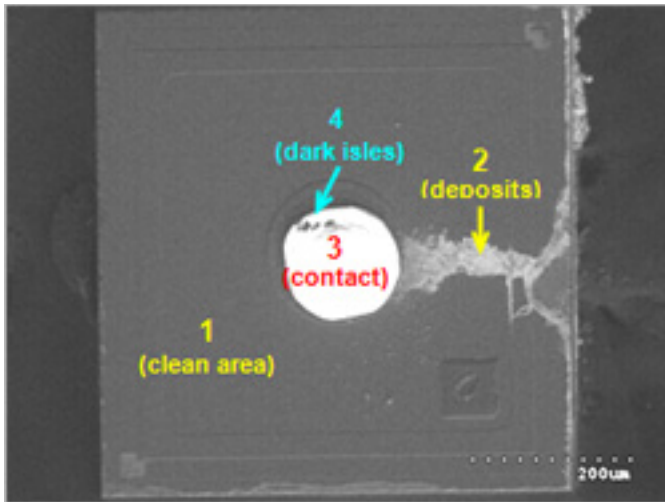
1. SEM examination of the photodiode chip revealed four distinct areas of interest (see Photos 1 – 3 below and on the following page). The areas were labeled as follows:

- 1 (clean area)
- 2 (deposits)
- 3 (contact)
- 4 (dark isles on contact).

Photo 1: SEM view of the photodiode chip. Mag: 100X

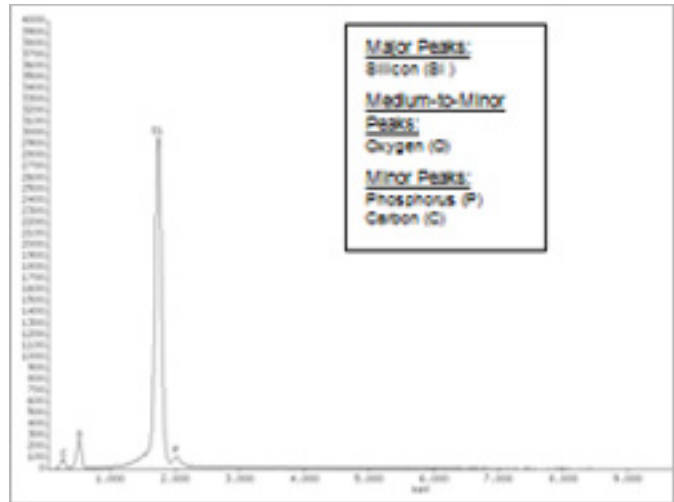
Figure 1: EDS spectrum of Area 1 (clean).

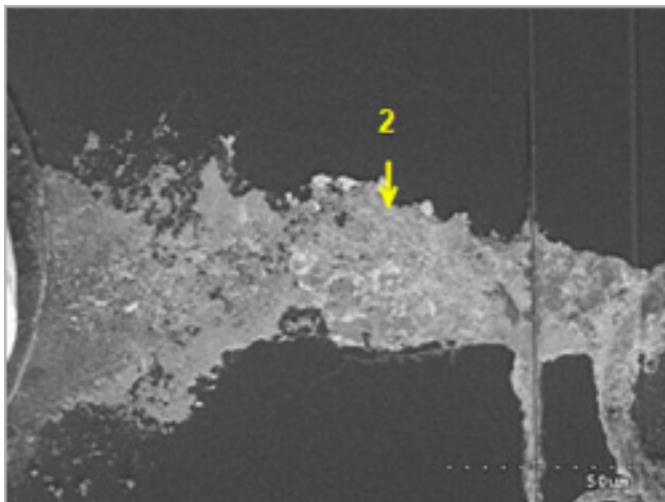
Photo 2: SEM view of Area 2 (deposits). Mag: 500X

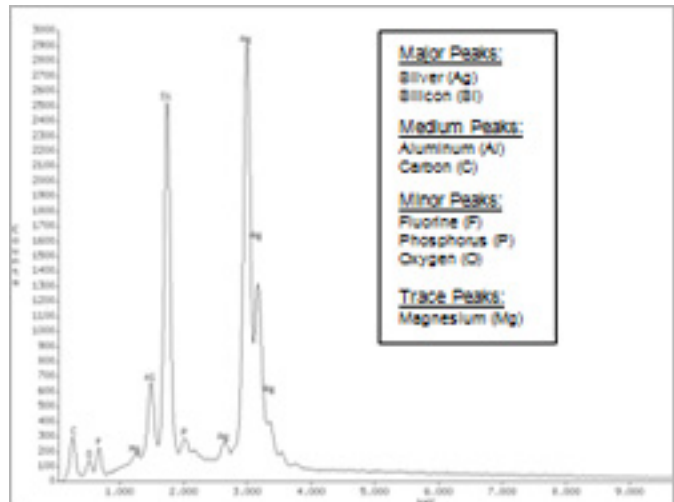
3. The morphology and elemental make-up of the examined surface features were summarized on the acquired SEM micrographs and EDS spectra.
4. Evaluation of the chip fabrication processes was not within the scope of this testing. However, it should be noted that (a) the presence of the fluorine peak implied a possibility of exposure of the silicon-base chip to a hydrofluoric acid treatment; (b) the carbon peaks are most likely attributable to the polymer residue; and (c) the magnesium peak is considered to be incidental.

Figure 2: EDS spectrum of Area 2 (deposits).

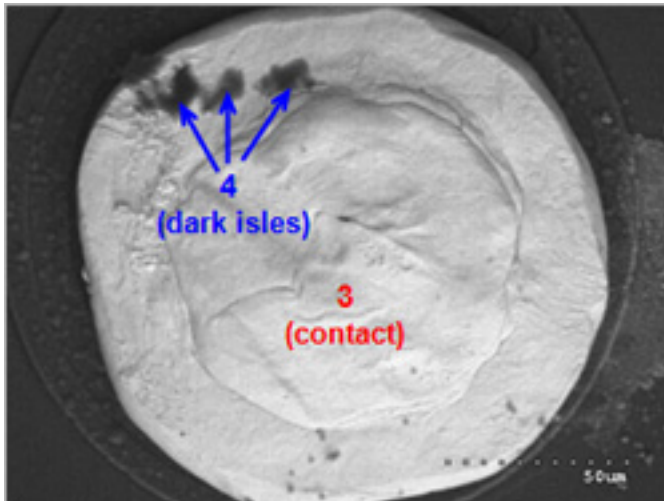
Photo 3: SEM view of Areas 3 and 4. Mag: 500X

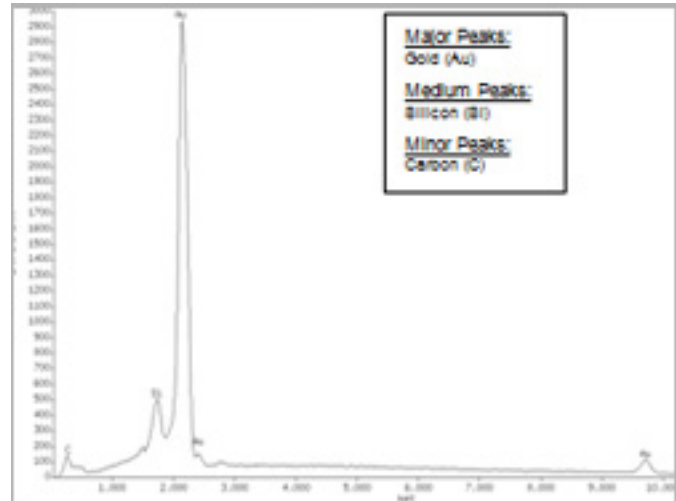
Figure 3: EDS spectrum of Area 3 (contact surface).

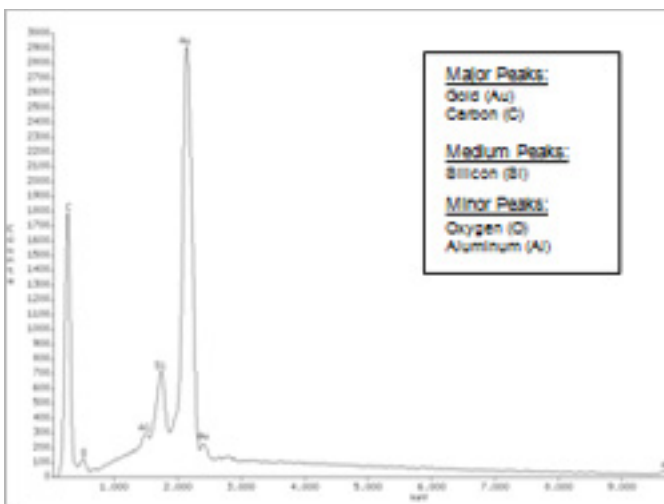
Figure 4: EDS spectrum of Area 4 (dark isles on contact).

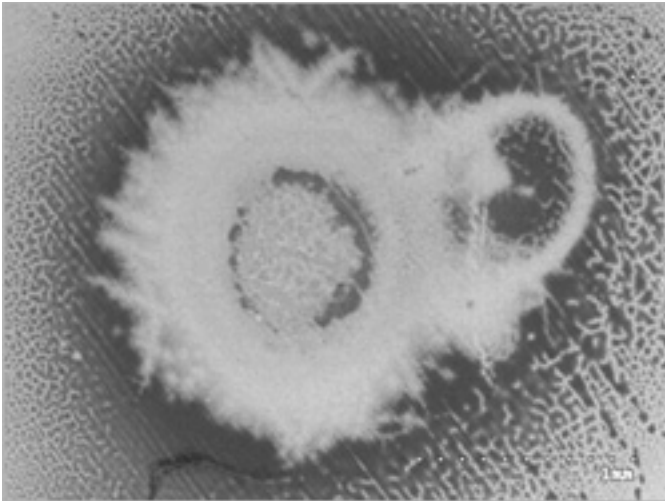
1. SEM examination of the cover plate surface revealed areas of discoloration forming sporadic spots on the painted surface (see Photos 4 – 5).
2. EDS spectra generated by the spots, along with a reference spectrum from the non-spotted area, are shown in Figures 5 – 7 below and on the following page. Major, minor and trace peaks on the spectra are identified on each corresponding Figure.
3. No information about the plate fabrication processes was available. However, it should be noted that the only detectable difference between the spectra generated by the discolored and non-discolored areas was the appreciably higher intensity of the carbon peak in the spotted areas. This observation implied that the discoloration

resulted from an exposure of the plate to some unidentified organic compound (solvent, lubricant, etc.).

Photo 4: SEM view of Spot #1. Mag: 30X

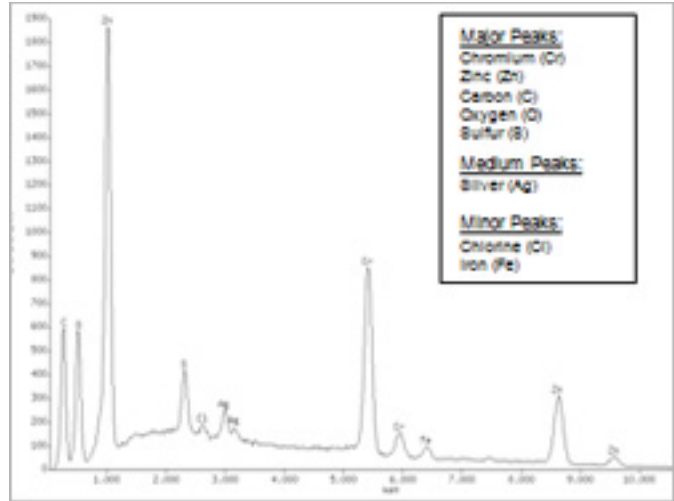
Figure 5: EDS spectrum of Spot #1.

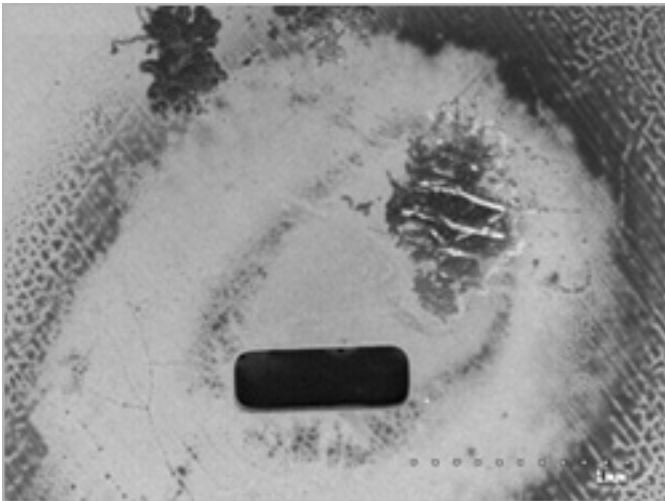
Photo 5: SEM view of Spot #2. Mag: 30X

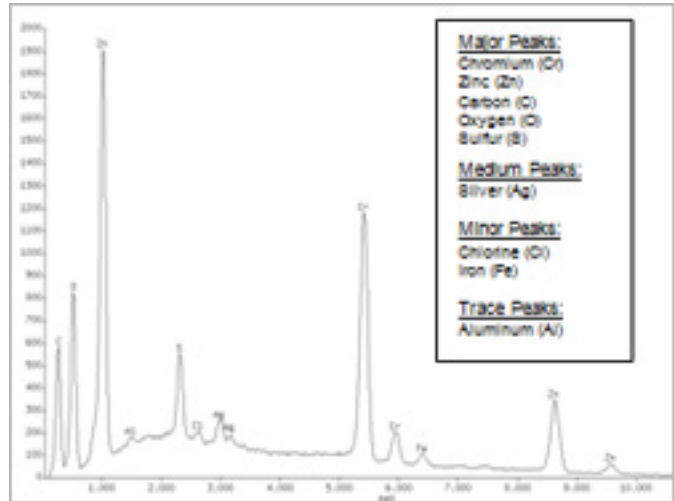
Figure 6: EDS spectrum of Spot #2.

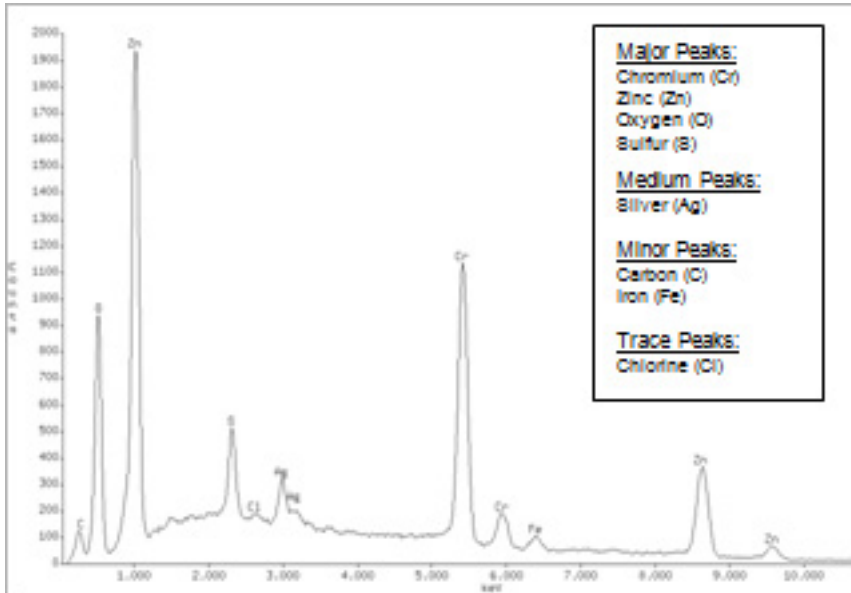
Figure 7: EDS spectrum of a random non-spotted area.
