MSi Testing & Engineering, Inc.

MSi Investigative Summary

Weld testing defect analysis of circumferential groove weld

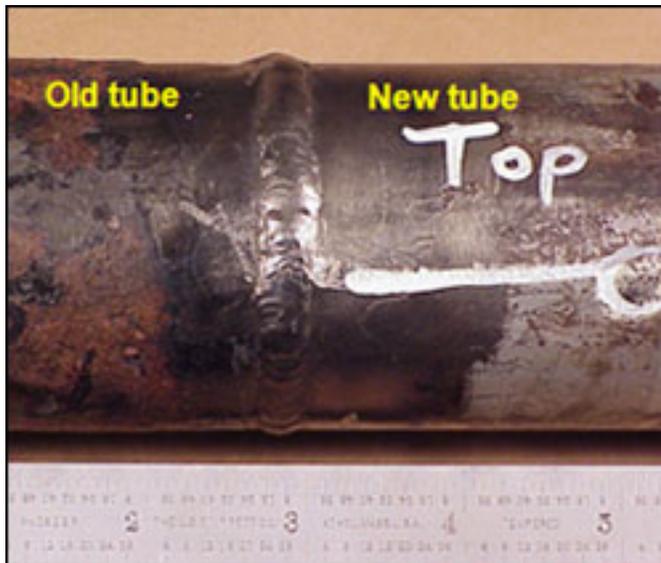
Visual and stereoscopic examination of the sample revealed a single, uniform filler metal bead on the OD of the top portion of the tube, and evidence of excessive weld root penetration on the corresponding ID areas. (See Photos 1 and 3).

Photo 1: Single weld bead on the OD of the top portion of the tube sample).

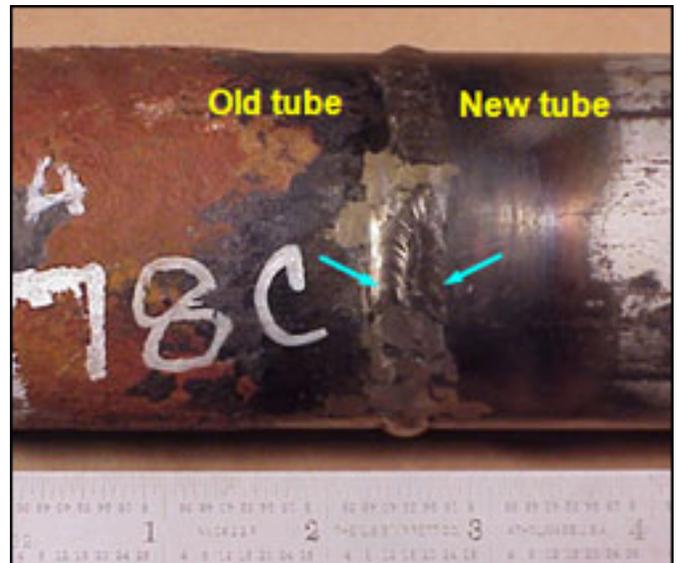
The bottom portion of the sample revealed two beads and evidence of surface grinding on the OD. The corresponding ID areas exhibited weld root concavity. (See Photos 2 and 4).

Photo 2: Two weld beads (arrows) on the OD of the bottom portion of the tube sample.

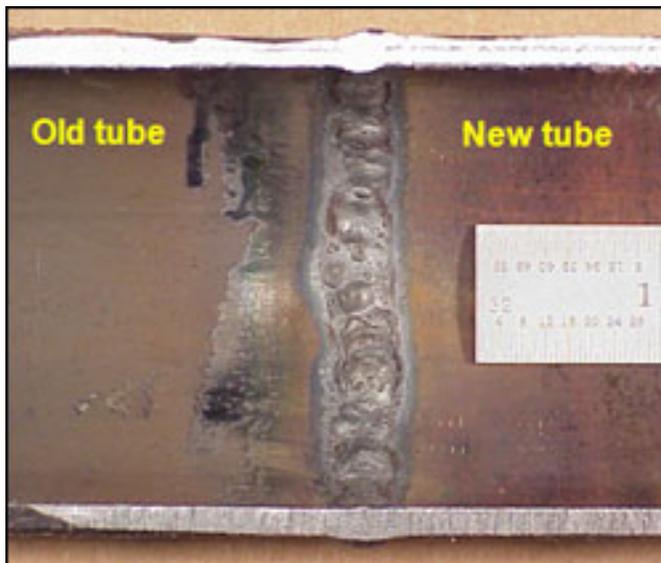
5. The face and the root surfaces on the examined circumferential weld also revealed some irregularities, associated with uneven welding speed and excessive heat input. This produced excessive weld root penetration areas in the sample portion marked “top”, along with some weld root concavity in the sample portion marked “bottom”.

Photo 3: Excessive root penetration on the ID of the top portion of the tube sample).

9. To alleviate excessive root penetration, root concavity and welding technique-related porosity defects in the weld joints, we respectfully recommend reviewing and adjusting the current welding procedures. Destructive examinations of weld test coupons will be helpful in improving the weld quality and eliminating the welding defects.

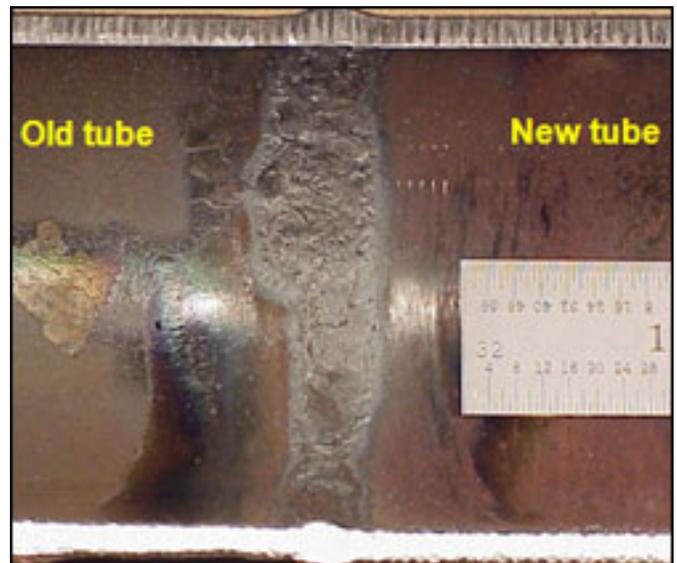
Photo 4: Concavity of the root on the ID of the bottom portion of the tube sample)

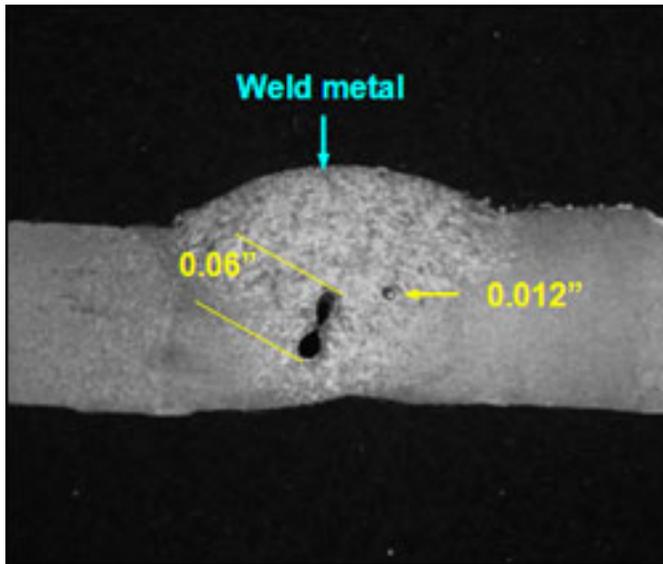
1. Based upon the performed tests and examinations, it is our opinion that the porosity defect in the circumferential weld was caused by welding technique deficiencies. The porosity was not caused by the filler metal or tubing material.

2. The defect was highly localized and contained a cluster of three (3) cavities. One cavity was spherical and measured ~.012" in diameter. The other two cavities were conjoined, elongated, and had an overall length of ~.06". The shapes of the observed cavities were characteristic of gas porosity (i.e., gas bubbles trapped inside the molten filler metal).

4. Welding-related porosity may result from the following causes:
 - Slow gas flow
 - A significant momentary change in the gas cup orientation
 - The arc is too long

- Too much electrode is extending beyond the gas cup end
- Intermittent drafts in the work area

cavities. One cavity was spherical and measured ~ 0.012 " in diameter. The other two cavities were conjoined, elongated, and had an overall length of ~ 0.06 ". The shapes of all observed cavities were characteristic of gas porosity defects (see Photo 5).

Photo 5: Porosity cluster in the weld metal (7 o'clock location on the tube circumference). Etchant: 3% Nital

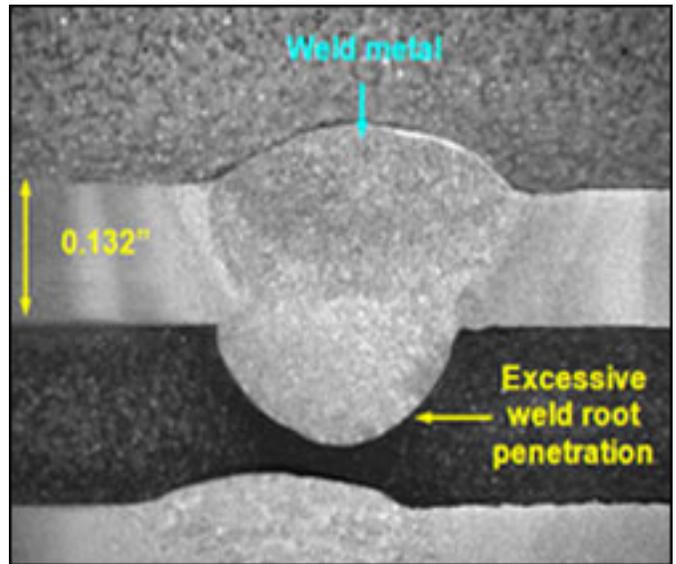
3. Examination of the four additional, reference weld sections revealed no evidence of porosity, cracking or detrimental inclusions. However, excessive weld root penetration and weld root concavity were observed at the top and bottom tube locations, respectively (see Photos 6 – 8).

Photo 6: Reference section 1 from the top portion of the tube sample. No porosity detected. Etchant: 3% Nital

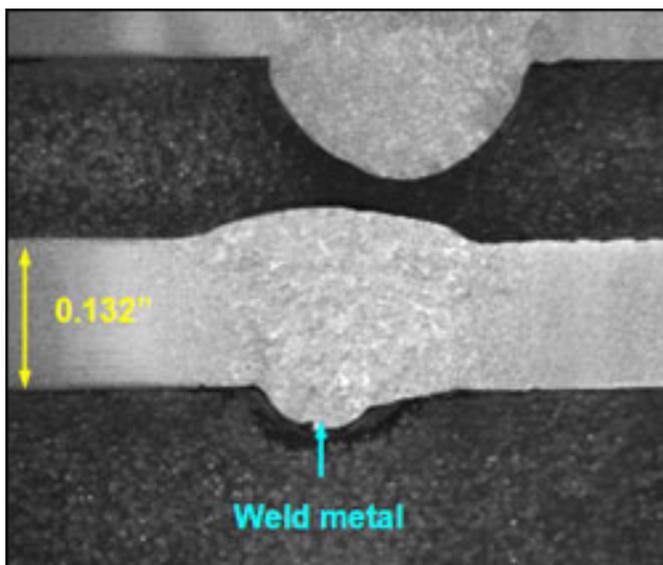
Photo 7: Reference section 2 from the top portion of the tube sample. No porosity detected. Etchant: 3% Nital

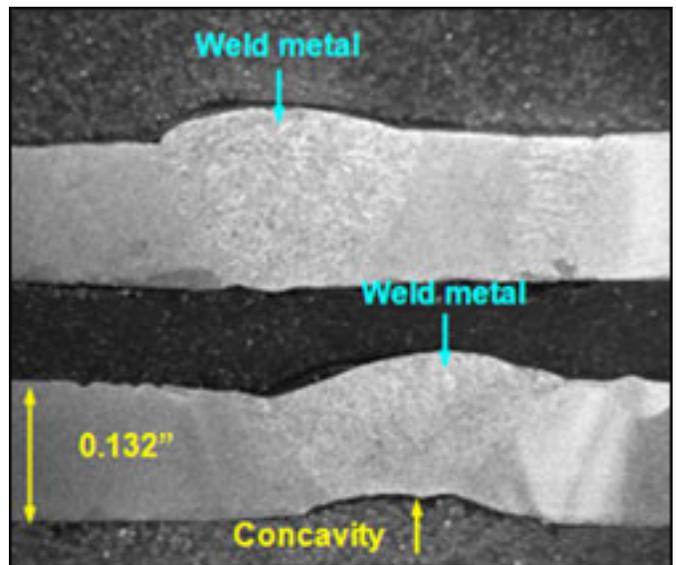
Photo 8: 2 reference sections from the bottom portion of

the tube sample. No porosity detected. Etchant: 3% Nital

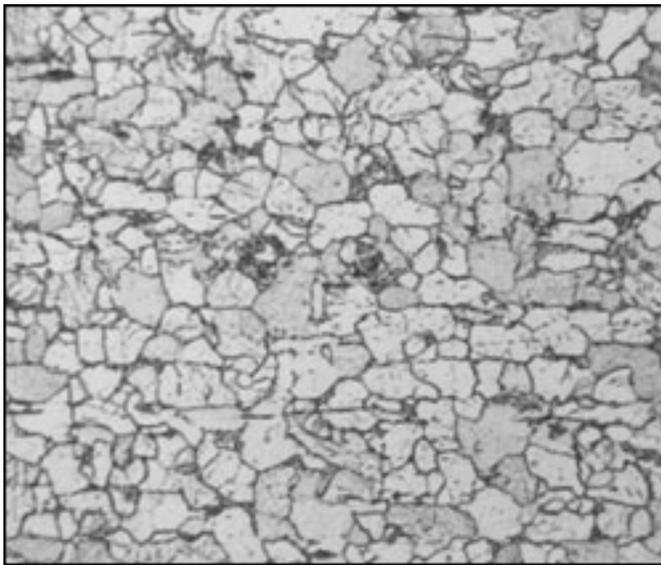
Metallographic examination of the “old” tube material revealed a microstructure consisting of ferrite and spheroidized pearlite, which is typical of low-carbon steel tubes exposed to boiler temperatures over a prolonged period of time. No evidence was observed of pre-existing steel defects, excessive nonmetallic inclusions, or any other detrimental material conditions (see Photo 9).

Photo 9:
“Old” tube microstructure.

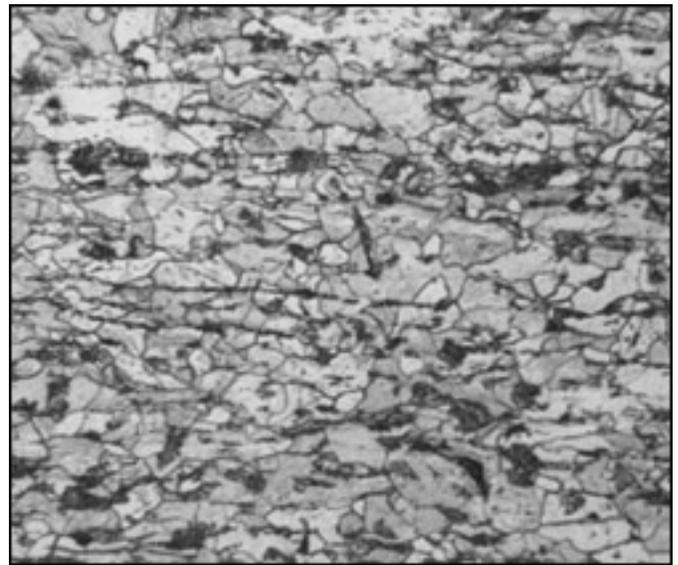
Metallographic examination of the “new” tube material revealed a microstructure consisting of ferrite and very fine unresolved pearlite, which is typical of alloy steel boiler tubes. No evidence was observed of pre-existing steel defects, excessive nonmetallic inclusions, or any other detrimental material conditions (see Photo 10).

Photo 10:
“New” tube microstructure.
