MSi Testing & Engineering, Inc.

MSi Investigative Summary

Two (2) partially machined impellers cast from C95200 aluminum bronze were submitted to our laboratory for casting failure analysis. The submitted castings identified as #1 and #3 exhibited casting surface defects primarily associated with the middle to OD sections of the impeller vanes.

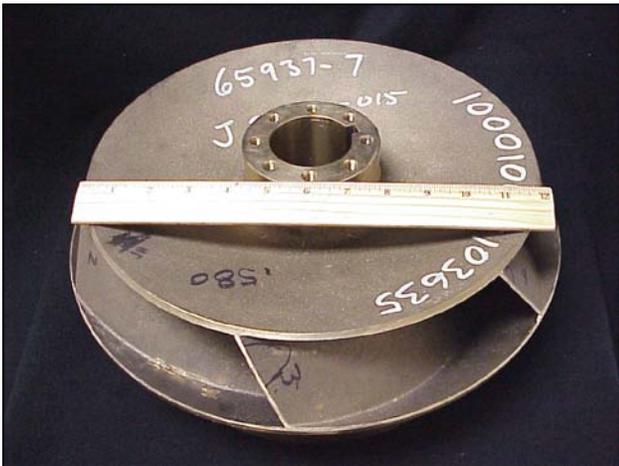
1. Visual and stereoscopic examination of Castings #1 and #3 revealed surface wrinkles and irregularities primarily associated with the middle to OD sections of the impeller vanes. The appearance of the wrinkles and irregularities suggested abnormal turbulence of metal within the mold cavity contributed to formation. (See Photos 1 – 4 on the following page)

Photo 1: View of Casting #1.

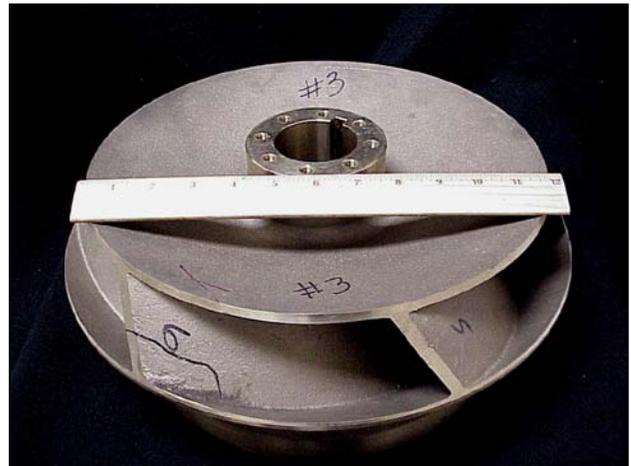
Photo 2: View of Casting #3.

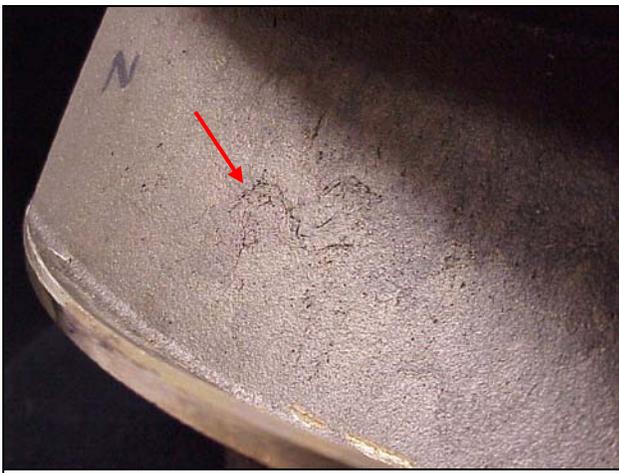
4. Visual and metallographic examination of the defect profiles revealed irregular surface wrinkles and subsurface folds of metal. Casting #1 exhibited the most severe defects, which on vane #2 extended through the full thickness of the vane. Metal folds and surface irregularities on casting #3 were predominantly confined to the surface, which were measured to a maximum depth of .010 – .012”.

Photo 3: View of defects on vane #2 of Casting #1. .

8. We respectively recommend that the venting design of the mold be reviewed to provide maximum release of gas produced from the cold box cores. Additionally, verify that proper procedures are followed during blow of SO₂ as catalyst during the production of the furan cold box cores to minimize reaction products formed in the mold during fill.

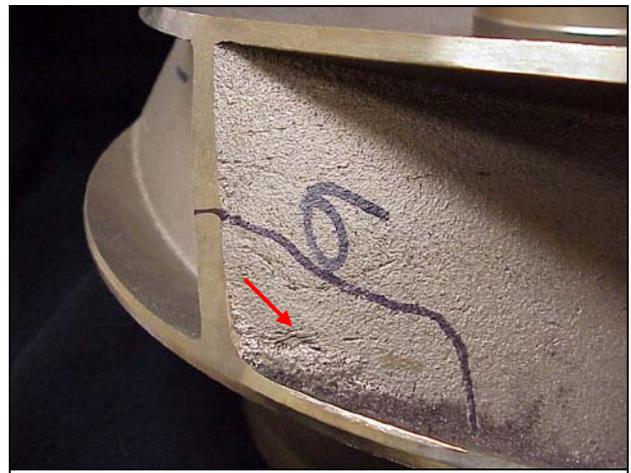
Photo 4: View of defects on vane #6 of Casting #3.

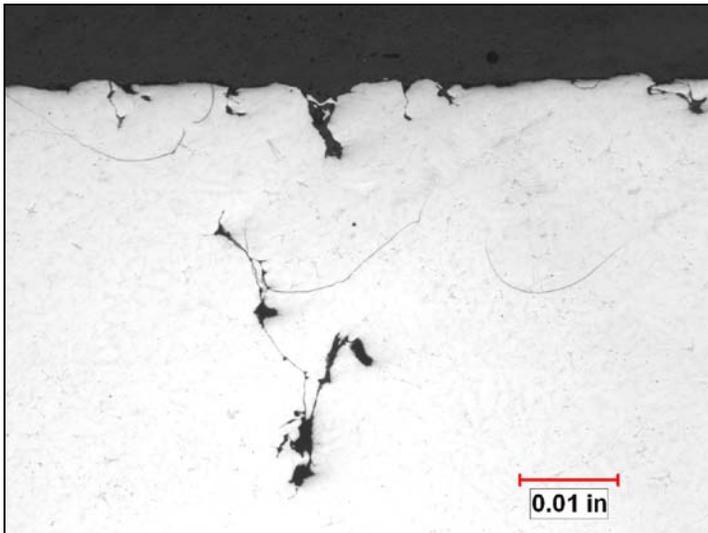
1. Metallographic examination of the defect profiles revealed irregular surface wrinkles and subsurface folds of metal. Casting #1 exhibited the most severe defects, which on vane #2 extended through the full thickness of the vane. (See Photos 5 and 6)
2. Metal folds and surface irregularities on casting #3 were predominantly confined to the surface, which were measured to a maximum depth of .010 – .012”.

Photo 5: Mag: 50X; Etchant: None
View of defect profile of Casting #1 at the surface of vane 2.

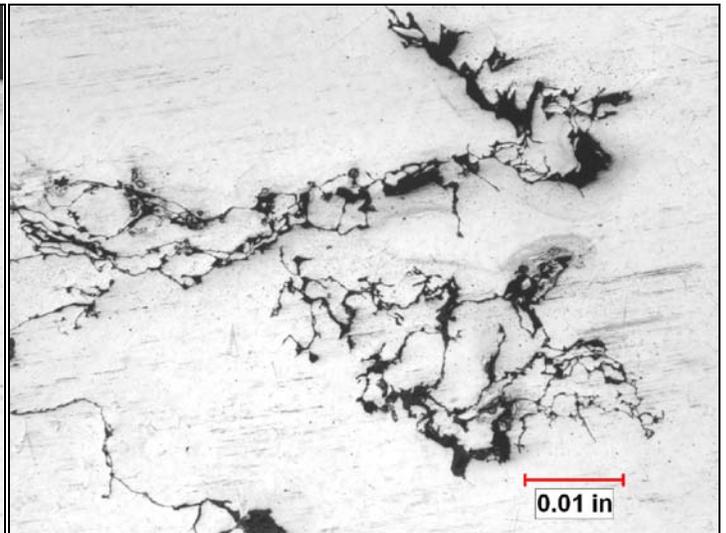
Photo 6: Mag: 50X; Etchant: None
View of defect profile of Casting #1 at the mid-wall of vane 2.

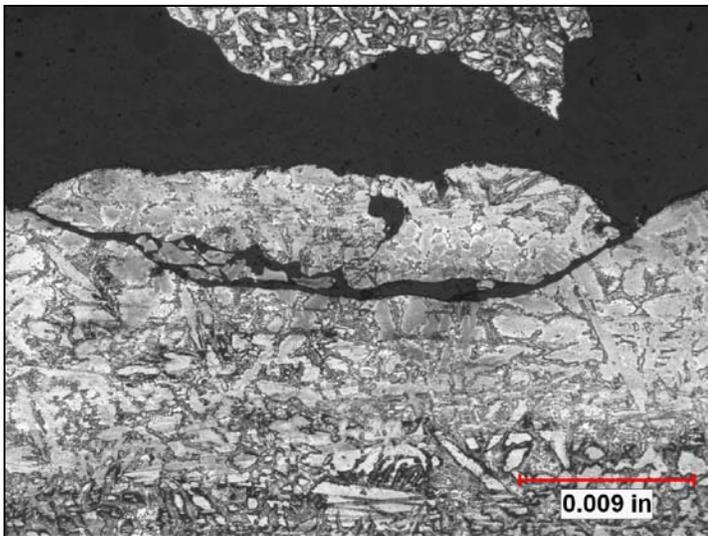
Photo 7: Mag: 100X; Etchant: NaOH₄ + H₂O₂
View of defect profile of Casting #3 at the surface of vane 6.

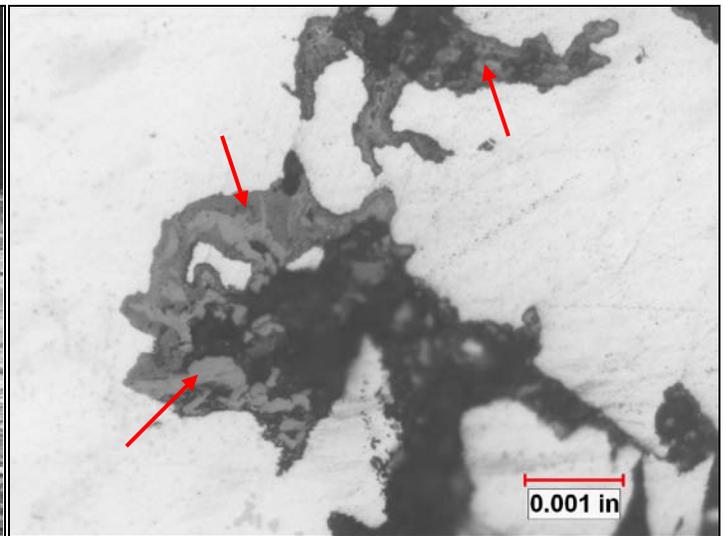
6. Energy dispersive spectroscopy (EDS) analysis of the foreign material lining the defects revealed a major elemental concentration of sulfur, which is not an element common to C95200 aluminum bronze.

Photo 8: Mag: 500X; Etchant: None
Close-up view of foreign material that lined the defect profiles.
The material was subjected to EDS analysis.

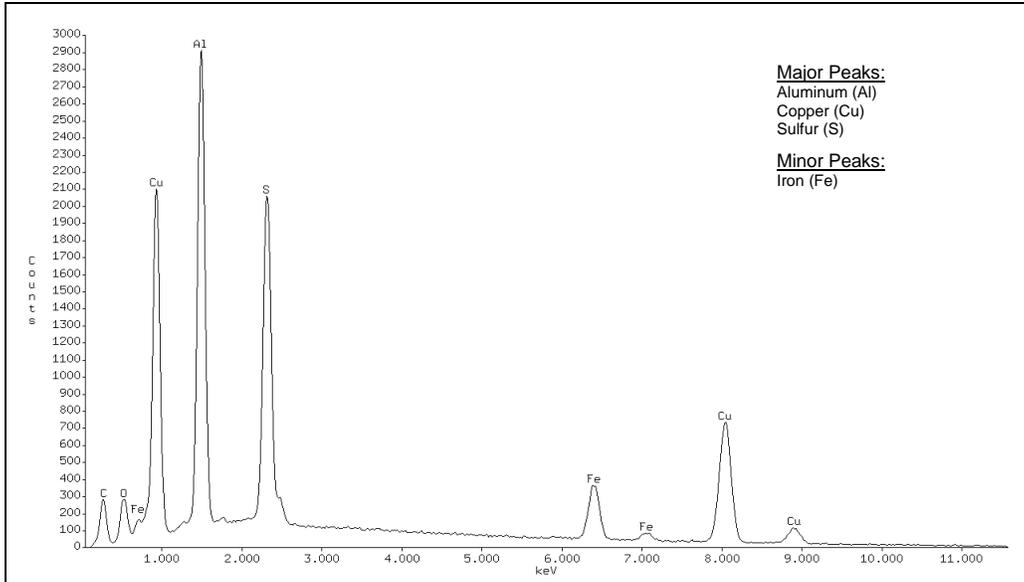
1. EDS analysis of the material lining the boundaries of the interior defect profiles of both samples revealed major elemental peaks of sulfur (S), aluminum (Al), copper (Cu) and a minor elemental peak of iron (Fe). Aluminum, copper, and iron are common to C95200 aluminum bronze. However, sulfur at high levels is not common to aluminum bronze.
2. The most likely source of the high level of sulfur is the furan cold box cores.
3. The EDS spectrum is shown in attached Figure 1.

Figure 1: EDS spectrum of the material lining the defects of Casting #1.
