MSi Testing & Engineering, Inc.

MSi Investigative Summary

Two (2) sections removed from a cast iron cylinder head were submitted to our laboratory for a metallurgical investigation. The submitted sections were identified as Sample #1 and Sample #2. Both samples exhibited sub-surface defects that were exposed during machining or cutting of the wall section. The cylinder head was reportedly poured with gray iron into a green sand mold. Hot box cores were also utilized, which were coated with a water based coating. We were requested to determine the nature of the defects and provide the following summary.

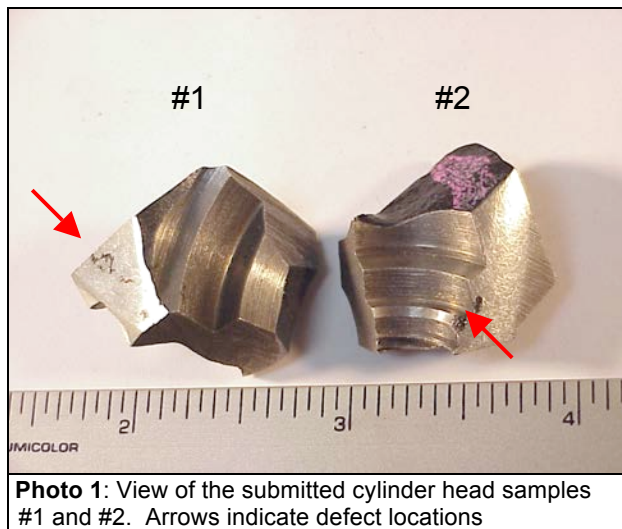
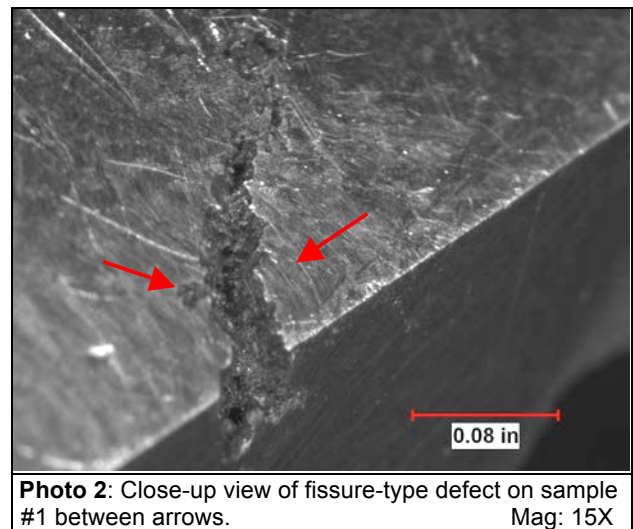
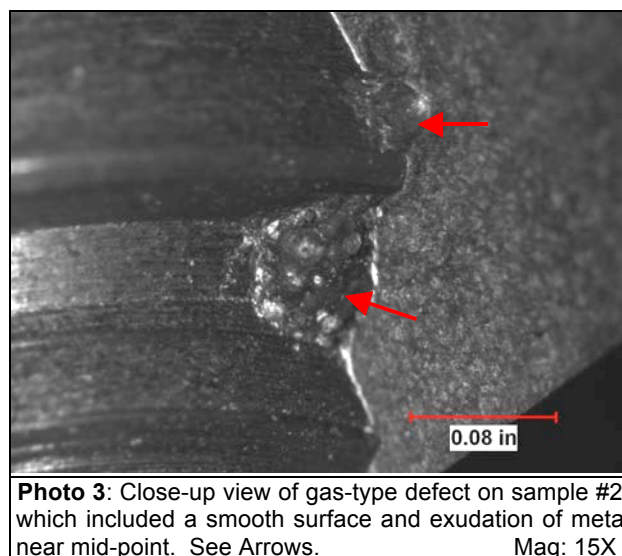
1. Based upon the performed tests and examinations, it is our opinion the cause of the sub-surface defects (voids) was gas-related. The shape, size, and interior microstructure characteristics indicate the defects formed from nitrogen gas. The origin of the nitrogen is most likely an external source, which would include nitrogen-bearing materials accumulating in the green sand system (molds), improperly cured cores, and core resins.
2. Visual and metallographic examination of the defect profiles revealed sub-surface cavities that varied from irregular and fissure-type in Sample #1 to relatively smooth exhibiting an exuded ball of metal at mid-point in Sample #2. The defect profiles were partially lined with a discontinuous layer of carbon. The flake graphite within the matrix extended into the defect cavities. These features are characteristic of nitrogen related gas porosity.

1. Visual and stereoscopic examination of Samples #1 and #2 revealed sub-surface cavities that were irregular and fissure-type in #1 to relatively smooth with an exuded ball of metal at mid-point in Sample #2. (See Photos 1 – 3)
2. The defect profiles in Photos 2 and 3 were sectioned and further examined using metallographic methods.

graphitizing inoculant containing a substantial amount of titanium, approximately 9.5%. Proper use will result in titanium levels of .02 – .04%, which will combine with excessive nitrogen to form titanium nitrides and minimize porosity from nitrogen gas.

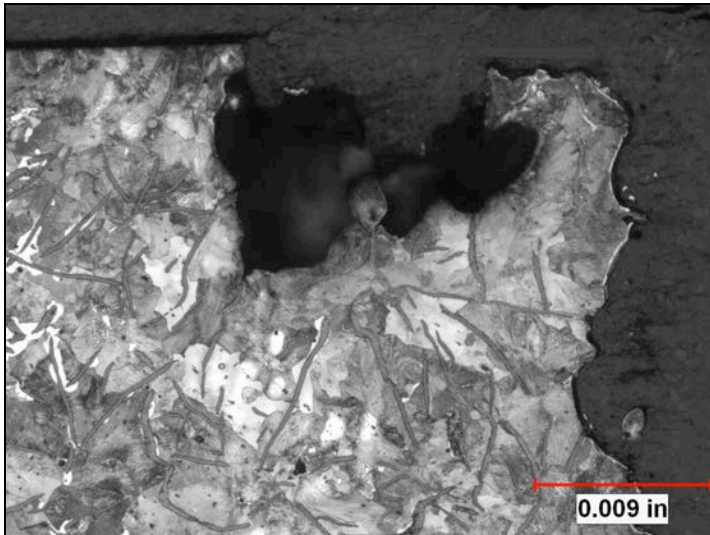
and the relatively smooth surface and exuded ball of metal in Sample #2. Both were partially lined with a discontinuous layer plus graphite flakes in the matrix extended into the cavities, which is characteristic of nitrogen related gas porosity. (See Photos 4 – 7)

Photo 4: Mag: 100X; Etchant: 3% Nital
Sample #1: Defect profile was irregular and fissure-type

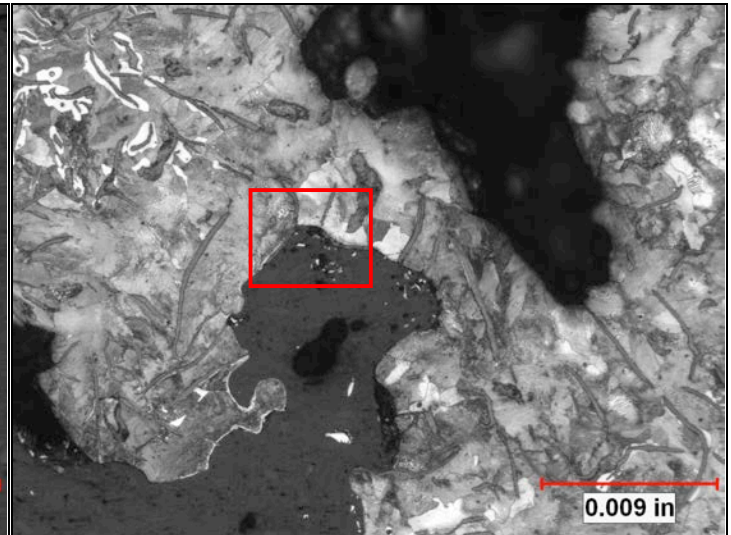
Photo 5: Mag: 100X; Etchant: 3% Nital
Sample #1: Defect profile lined with discontinuous layer.

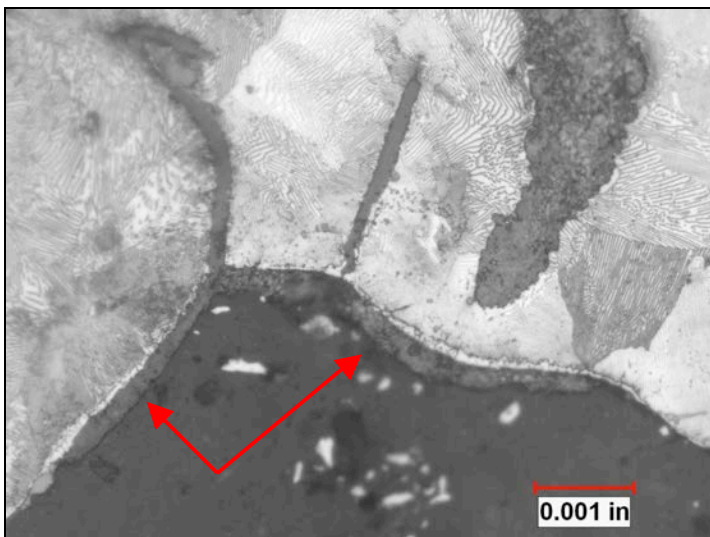
Photo 6: Mag: 500X; Etchant: 3% Nital
Close-up view of inset in Photo 5 showing a layer lining the defect.

3. The discontinuous layer of material lining the defect profiles as seen in Photos 6 and 7 was subjected to EDS analysis.

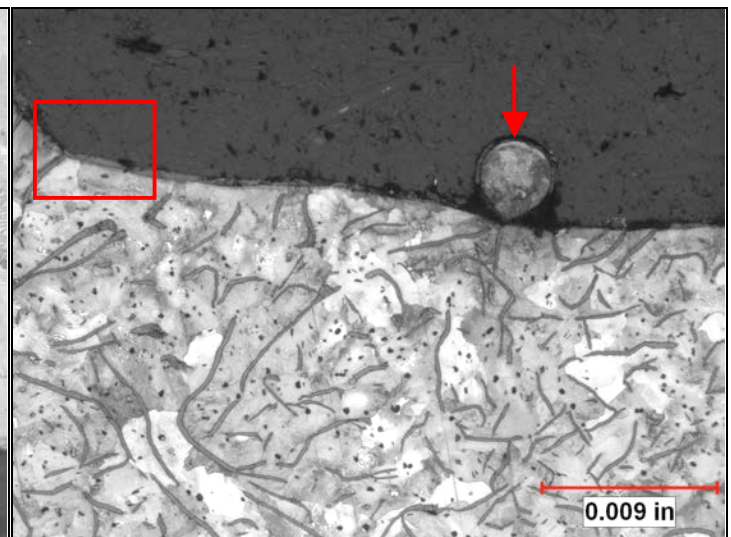
Photo 7: Mag: 100X; Etchant: 3% Nital
Sample #2: Exuded metal ball at midpoint of defect.

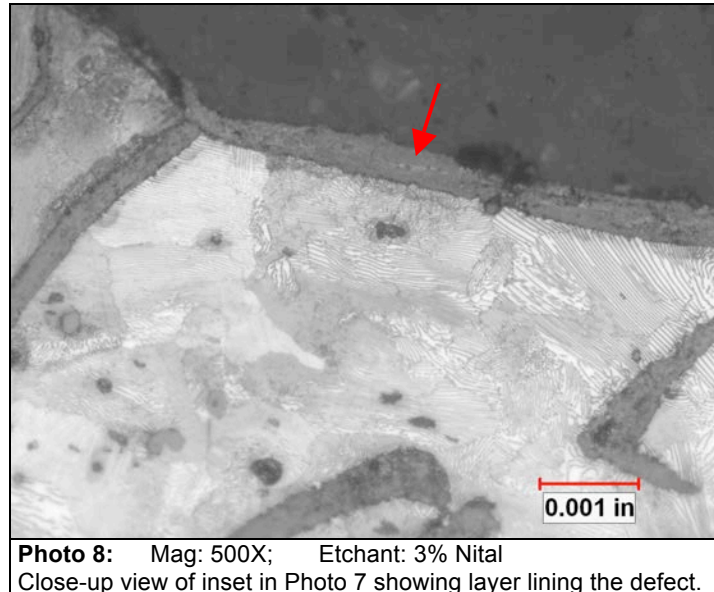
1. EDS analysis of the discontinuous layer lining the defects revealed a major elemental peak of carbon and minor elemental peaks of for silicon, aluminum, iron, calcium, and oxygen. The results indicate the layer was primarily graphite (carbon), which is a common characteristic of a gas cavity formed from nitrogen gas.
2. See attached Figure 1.
