# MSi Testing & Engineering, Inc.

## *MSi Investigative Summary*

### **BACKGROUND**

Two (2) forged drag chains identified as MCV and 4B were submitted to our laboratory for a metallurgical investigation. Sample MCV exhibited a complete fracture through the single hole end with significant surface wear along the side of the chain. Sample 4B exhibited no evidence of cracking or surface wear. Drag chains are part of a drag assembly used to convey limestone and bentonite clay from rail hoppers to a bucket conveyor.

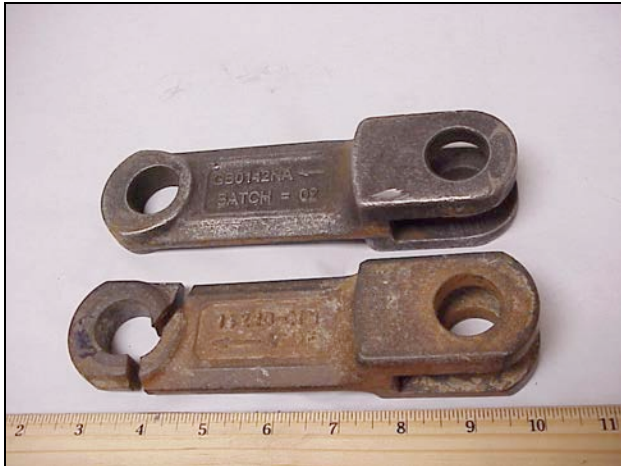
1. Sample MCV exhibited a complete fracture through the single 1" hole end and significant surface wear along the side of the chain. The sides of the chain correlate to the "flash" line formed during the hot forge and trimming operation. The "flash" line surface was also carburized during heat treatment and became severely worn during in-service conditions. (See Photos 1 – 4 on the following page)

**Photo 1:** View of the submitted Chain samples showing fractured MCV at the bottom and 4B at top.

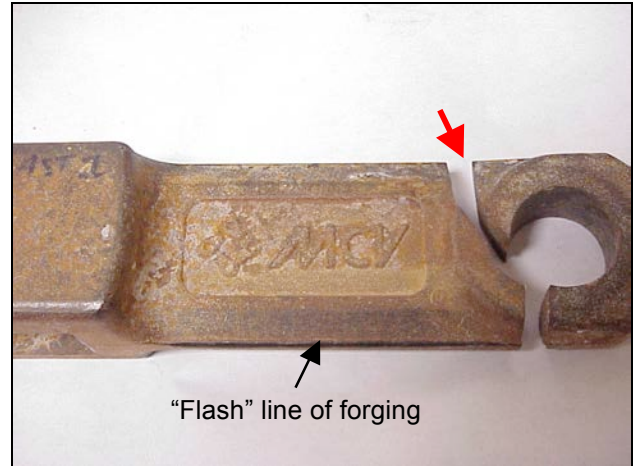
**Photo 2:** Close-up view of MCV and the location of the fracture at red arrow. Photo 3 shows cleaned fracture.

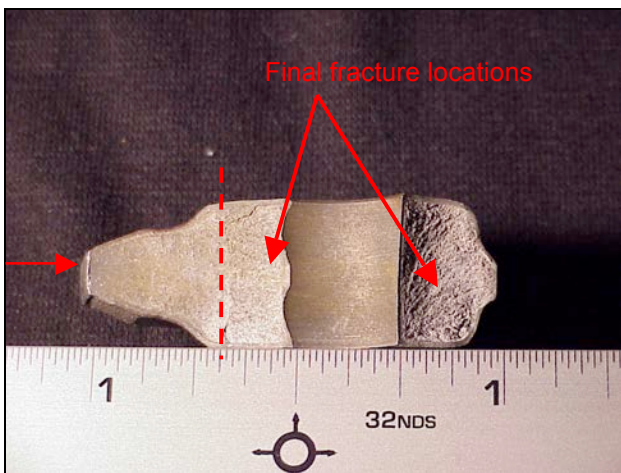
2. The fracture surface of MCV was ultrasonically cleaned to remove any loose debris and to reveal any distinguishing characteristics. Cleaning revealed a "thumbnail" pattern from the side of the chain that extended into the core, which was typical of a fatigue failure. (See Photo 3 on the following page)

3. The balance of the fracture was classified as the final fracture zone as shown in Photo 3.
4. A close up view of the fracture origin associated with the worn surface of the chain is shown in Photo 4.

**Photo 3:** View of "thumbnail" pattern from red arrow to dashed red line, which was typical of fatigue failure. The red arrow also indicates the origin of failure, which was severely worn from in-service loading conditions.

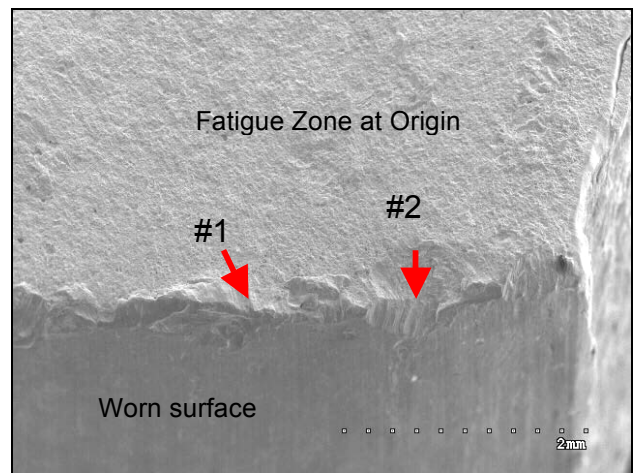
2. Applied in-service loading of the 5/32" wide trim-line of the chain (forging) abrasively removed the entire effective case of .030". Removal of the hardened carburized case resulted in the initiation of fatigue cracks in the lower subsurface hardness of core material. Continued in-service loading stresses after abrasive removal of the effective case caused the fatigue crack to propagate to an approximate depth of 5/8". Final ductile overload failure occurred when the remaining cross section adjacent to the pinhole could no longer support the applied load.

**Photo 4:** Close-up view of the severely worn surface that served as the origin of fatigue cracking. Two indents at red arrows served as stress concentrators. Mag: 15X

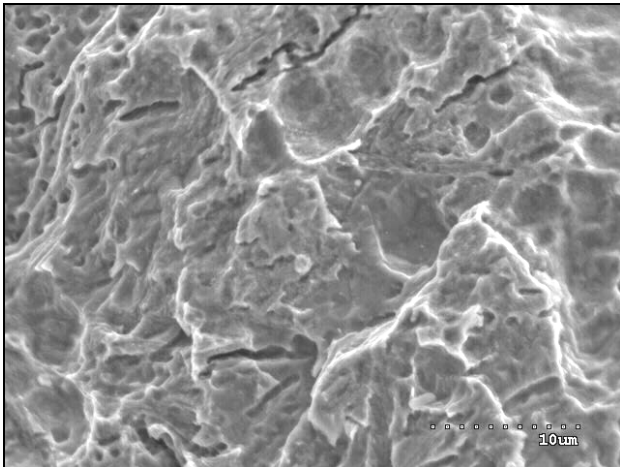
1. Scanning electron microscope (SEM) examination of the fracture features of chain MCV revealed striations (microscopic crack progression marks) associated with the origins at the worn surface, which verified failure of the chain was the result of fatigue. The striations were mildly oxidized, which altered their appearance and indicated fatigue cracking occurred over a period of time. Fine imperfections on the worn surface served as stress concentrators and sites of initial fatigue cracking. (See Photos 4 – 6)
2. Scanning electron microscope examination of the fracture features associated with the zones of final fracture revealed a dimpled surface, which was characteristic of ductile overload. (See Photos 7 and 8)

**Photo 5** – Fracture features of origin #1 Mag: 1900X  
SEM view of striations at origin associated worn side.

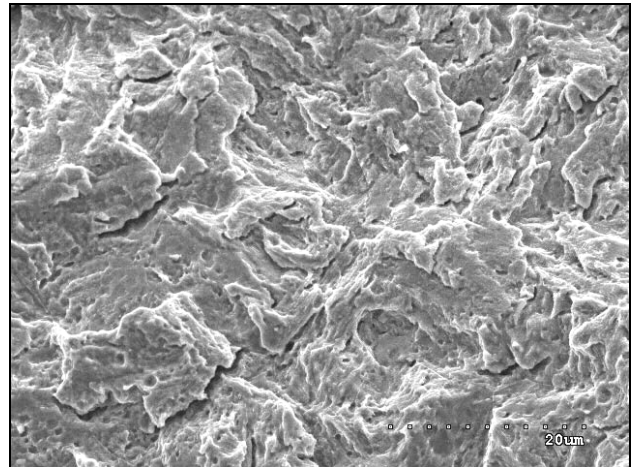
**Photo 6** – Fracture features of origin #2. Mag: 1300X  
SEM view of striations at origin associated with worn side

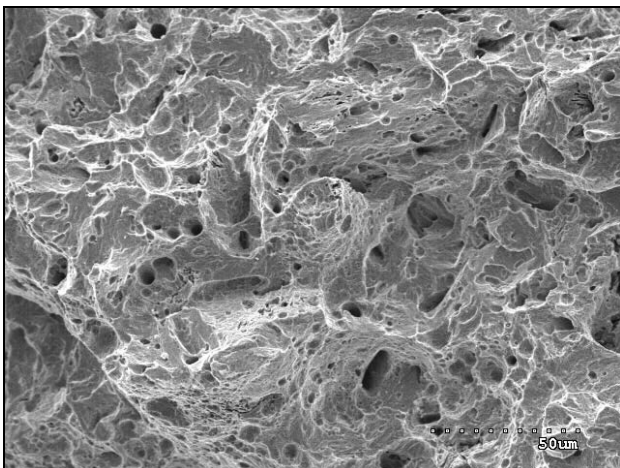
**Photo 7** – Features of final fracture Mag: 400X  
SEM view of a dimpled fracture, typical of a ductile overload final fracture.

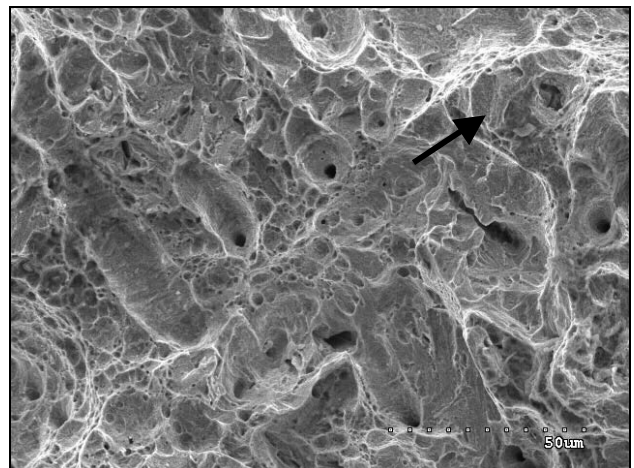
**Photo 8** – Features of final fracture Mag: 500X  
SEM view of a dimpled fracture, typical of a ductile overload final fracture.

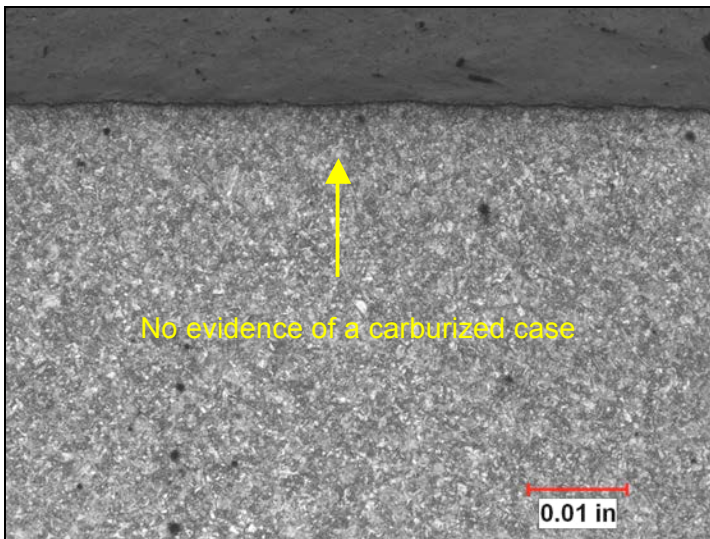
4. Metallographic examination of the side of the chain that served as the origin revealed evidence of directionally cold worked grains and no evidence of a carburized case. The case was worn away during in-service conditions. The fracture path associated with the fatigue zone was transgranular, typical of a fatigue failure. No evidence was observed of quench cracking or pre-existing material defect conditions.

1. Examination of the fracture profile at the origin of failure of Chain MCV revealed the carburized case was removed from the side of the chain during in-service loading conditions. The same location of Chain 4B revealed a carburized case to a depth of .038". (See Photos 9 & 10)
2. Examination of the surface microstructure of Chain MCV away from the fracture origin revealed a total carburized case to a depth of .035". The microstructure of the case consisted of small amounts of retained austenite in a matrix of tempered martensite. The same location of Chain 4B revealed a similar case microstructure. (See Photos 11 & 12)

**Photo 9:** Mag: 50X; Etchant: 3% Nital  
Chain MCV: No evidence of any carburized case at fracture origin.

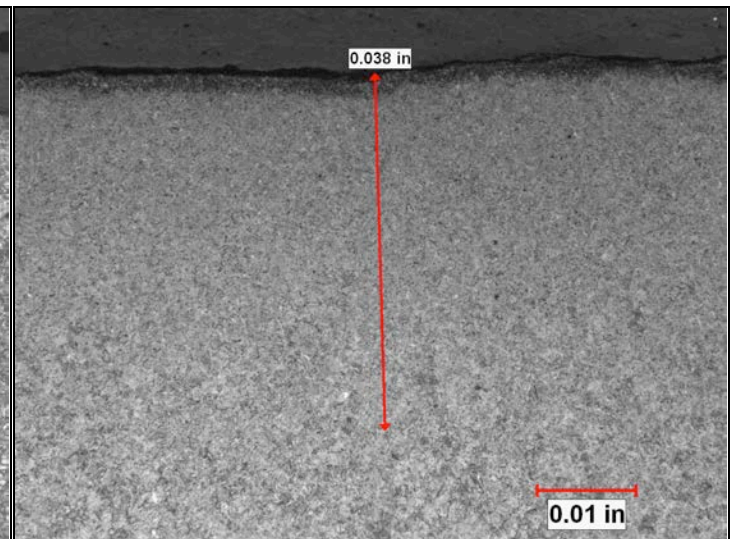
**Photo 10:** Mag: 50X; Etchant: 3% Nital  
Chain 4B: Carburized case at same location in Photo 9. Depth of case on "flash" line observed to a depth of .038".

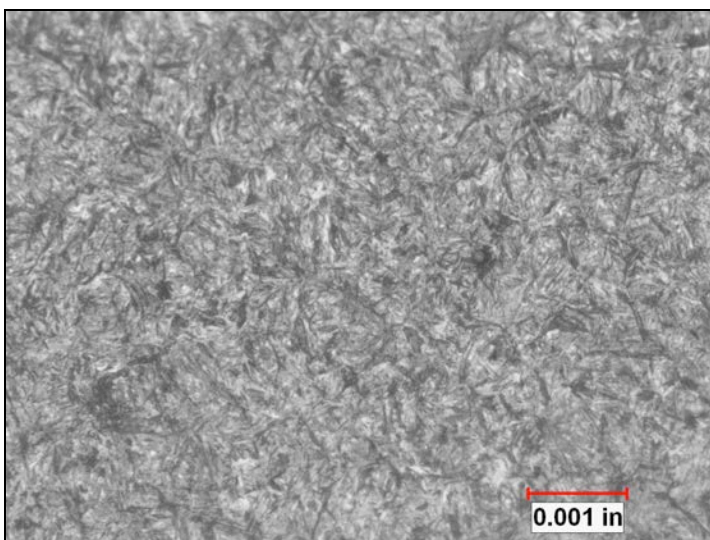
**Photo 11:** Mag: 500X; Etchant: 3% Nital  
Chain MCV: The carburized case away from the fracture origin consisted of small amounts of retained austenite in a matrix of tempered martensite. Hardness = 60 HRC

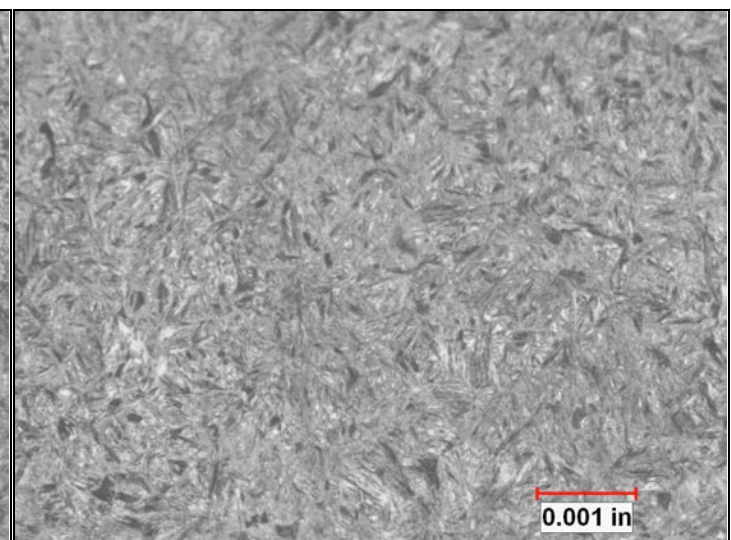
**Photo 12:** Mag: 500X; Etchant: 3% Nital  
Chain 4B: The carburized case at the same location consisted of small amounts of retained austenite in a matrix of tempered martensite. Hardness = 59 HRC

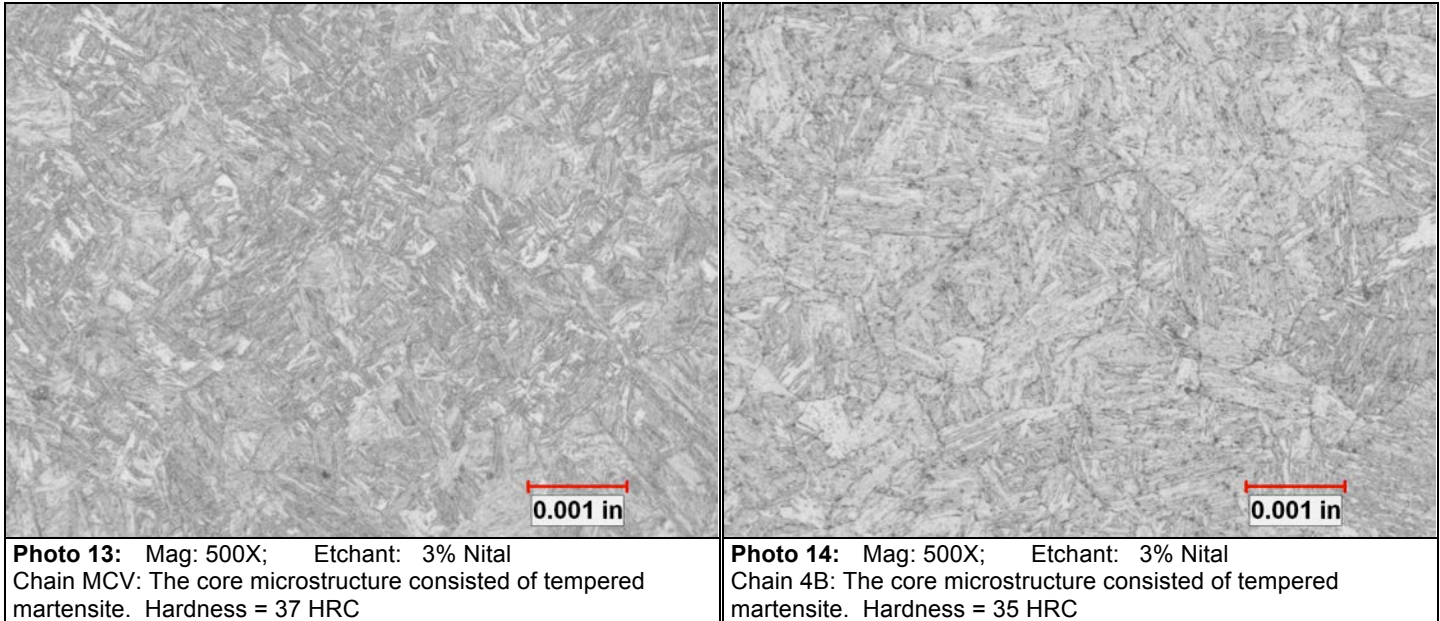
1. Examination of the core of both Chain samples revealed similar microstructures, which consisted of tempered martensite. The boron treated steel used in Chain MCV contributed to increased hardness. (See Photos 13 & 14)
2. The core microstructure of both samples indicates that the two chains were subjected to quench hardening and tempering after carburization of the surface.
