MSi Testing & Engineering, Inc.

MSi Investigative Summary

BACKGROUND

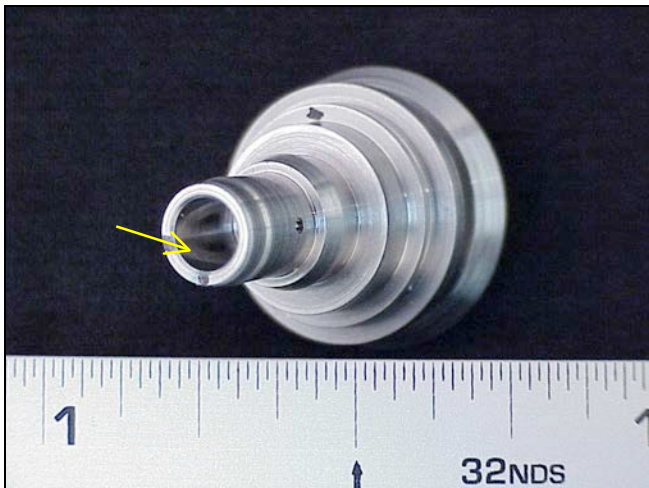
1. SEM examination of the ID surface revealed a faint, intermittent, linear surface defect indication along the .234" diameter ID surface. (See arrows in Photos 1 - 2).
2. Examination at higher magnification showed evidence of disturbed metal, most likely from the machining tool (see Photos 3 - 4). No evidence was observed of a pre-existing internal steel defect or inclusion stringer on the ID surface.

Photo 1: Submitted part with surface defect indication on the ID surface, denoted by the yellow arrow. 1.5X

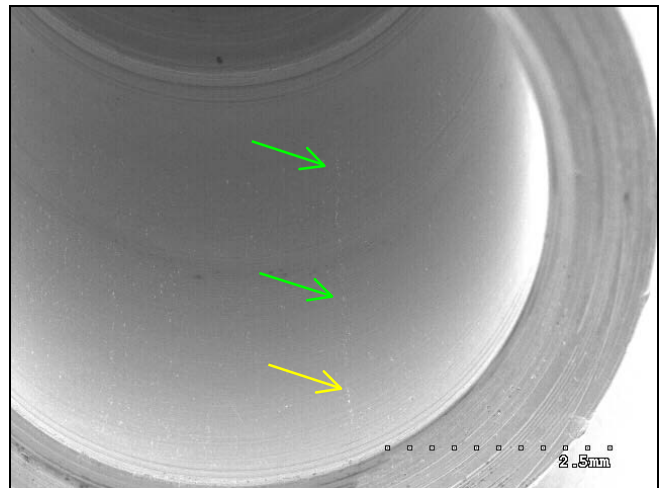
Photo 2: SEM image showing the faint linear defect indication on the machined ID surface. 10X

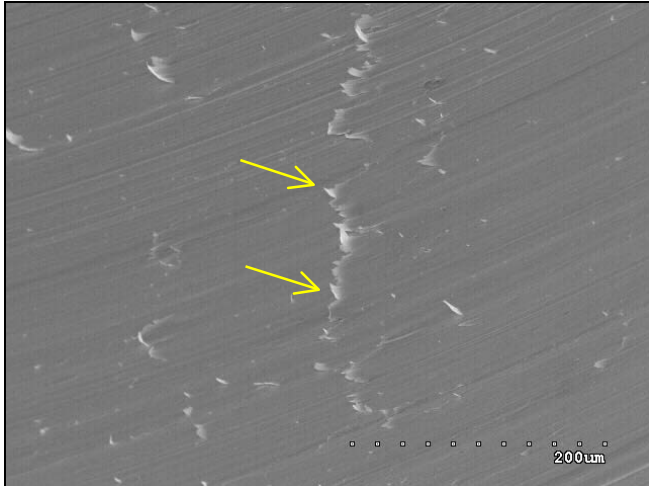
Photo 3: Close-up view of linear defect indication denoted by the yellow arrow in Photo 2. 165X

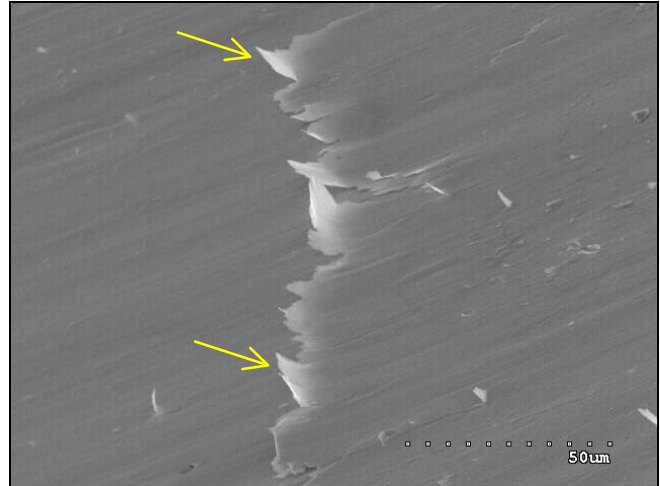
1. Based upon the performed examinations, it is our opinion the ID surface of the part, as identified by the failure analysis testing, contained a faint, intermittent, tool mark that was induced during the machining operation.
2. No evidence was observed of a pre-existing internal steel defect or inclusion stringer on the ID surface that could have caused the defect indication.
3. The microstructure as determined by the metal test lab was typical of AISI 1215 steel.

Photo 4: Higher magnification view of Photo 3 showing a tool mark from the machining operation. 1350X

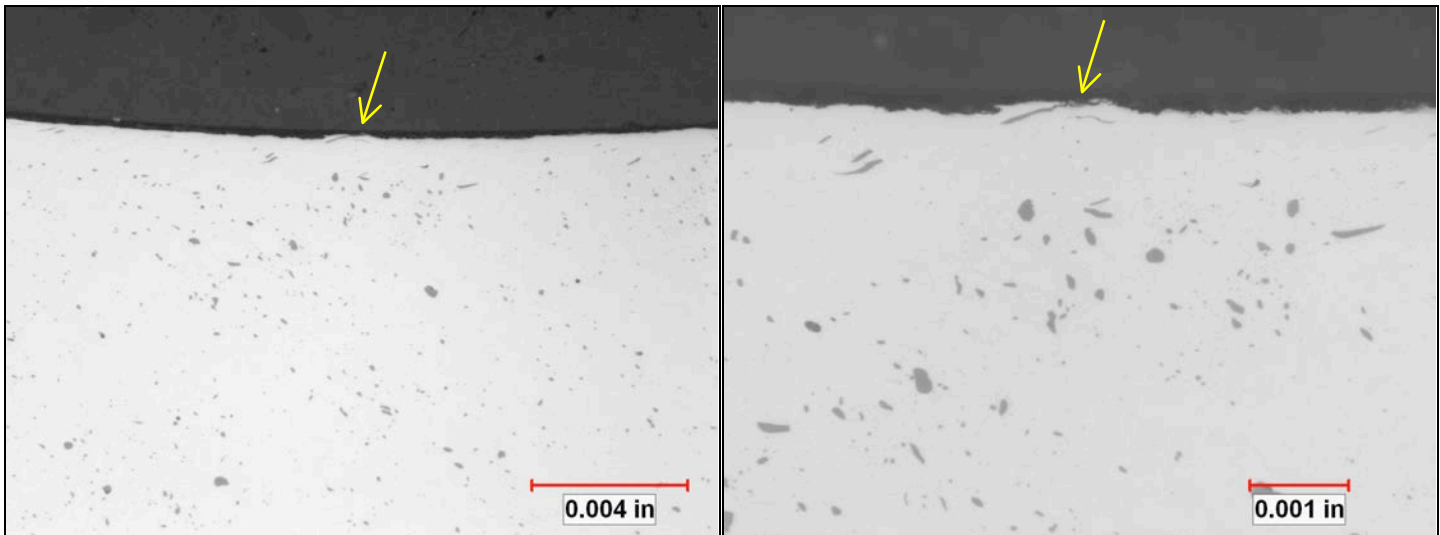
1. A transverse section removed from the region containing the ID surface defect indication confirmed the presence of a tool mark that was induced during the machining operation. (See arrow in Photos 5 - 6)
2. No evidence was observed of an abnormal inclusion content or any other detrimental internal conditions that could have caused the defect indication.
3. The microstructure consisted of pearlite and grain boundary cementite in a matrix of ferrite, typical of AISI 1215 steel.

Photo 5: Mag: 200X; Etchant: None
Cross-sectional view of stress crack initiating from .037" deep seam (at arrow).

Photo 6: Mag: 500X; Etchant: None
High magnification view of seam profile showing decarburization and dispersed oxides.
