MSi Testing & Engineering, Inc.

MSi Investigative Summary

Two (2) ductile iron castings identified as Brake Heads were submitted to our laboratory for [failure analysis testing](#). Sample #1 exhibited a complete fracture of the brake shoe arm near the inside pocket location of the head. Sample #2 exhibited a partial crack between an outer rib of the brake shoe arm and head.

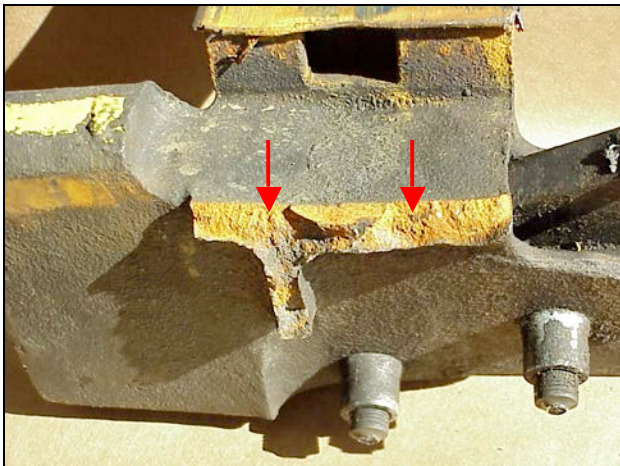
1. Examination of the submitted brake head castings revealed a complete fracture of Sample #1 and cracking of Sample #2 from the brake shoe arm and the inner pocket location of the head. The amount of oxidation of the fracture was significant and after cleaning masked some of the fracture features. (See Photos 1 and 3)
2. Visual examination of exposed and cleaned fractures revealed similar sites of initial cracking along the inner pocket radius location of the head and arm. The fracture features of Sample #1 exhibited a chevron pattern emanating from the pocket radius, which indicated the area was the site of initial cracking. The exposed fracture surface of Sample #2 revealed no informative features due to corrosion. (See Photos 2 and 4)

Photo 1: Submitted Sample #1, fracture at arrows.

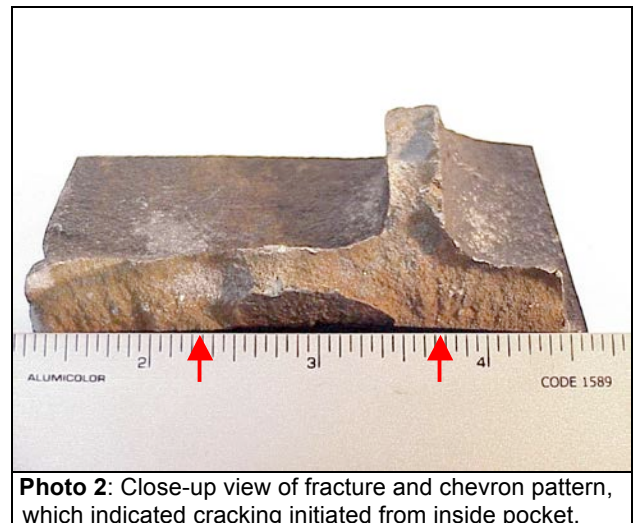
3. Visual examination of exposed and cleaned fractures revealed similar sites of initial cracking along the inner pocket radius location of the head and arm. The fracture features of Sample #1 exhibited a chevron pattern from the pocket radius, which indicated the area was the site of initial cracking. The exposed fracture surface of Sample #2 revealed no informative evidence due to oxidation (corrosion).

Photo 2: Close-up view of fracture and chevron pattern, which indicated cracking initiated from inside pocket.

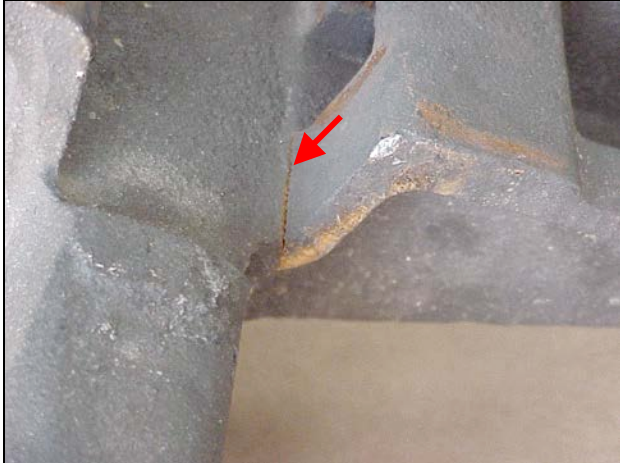
Photo 3: Submitted Sample #2, cracking at arrow.

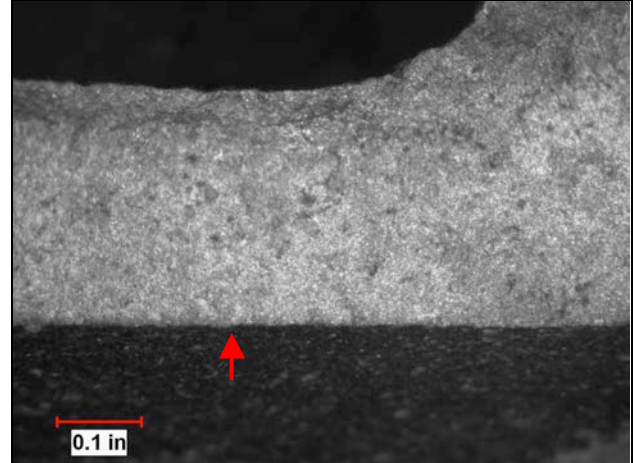
Photo 4: Close-up view of exposed fracture. The arrow indicates the inside pocket surface. Mag: 7X

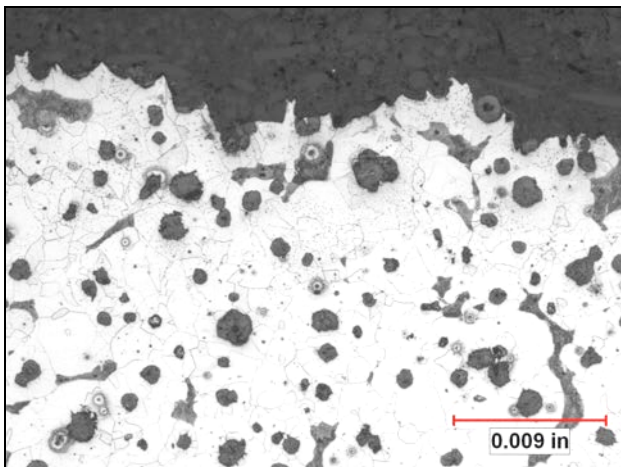
1. Transverse sections were removed through the fracture of Sample #1 at two locations indicated with arrows in Photo 2. Examination of the graphite morphology showed a uniform distribution of graphite nodules, typical of properly cast ductile iron. The graphite characteristics are described in the following table and shown in Photos 5 and 6.

Photo 5: Mag: 100X; Etchant: 3% Nital
Sample #1 - fracture surface, Type I & II graphite, size 6 and 7.

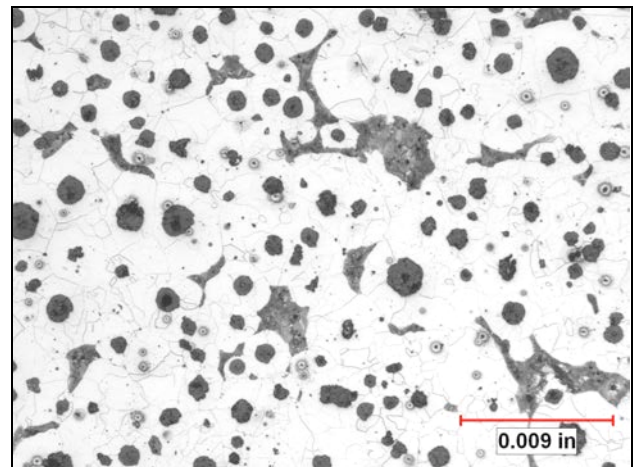
2. The matrix microstructure of Sample #1 consisted of 7 – 10% pearlite in a matrix of ferrite. (See Photo 6)
3. The surface microstructure along the inner pocket location of Sample #1 contained some magnesium-silicate stringers (dross inclusions), which were not considered excessive. The most severe dross stringers were measured to a depth of .002” below the surface. (See Photo 7 on the following page)
4. No evidence was observed of any intercellular carbide, carbide network, porosity, or any detrimental material defect conditions that could have contributed to the failure. (See Photo 8 on the following page)

Photo 6: Mag: 100X; Etchant: 3% Nital
Sample #1 – at core, Type I & II graphite, size 6 and 7.
Matrix: 7 – 10% pearlite in ferrite.

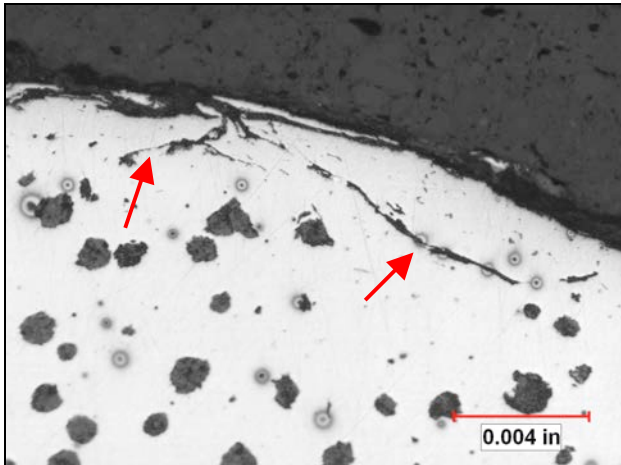
4. Metallographic examination of sections through the fracture of Sample #1 revealed an "as-cast" surface condition along the cast surface that consisted of some magnesium-silicate stringers (dross inclusions) to a depth of .002". The amount and depth of the dross stringers were not considered excessive. However, the stringers potentially serve as stress-concentrators during rapid loading and could serve as sites for fatigue cracking.

Photo 7: Mag: 200X; Etchant: None
Sample #1 – Magnesium-silicate stringers to a depth of .002” below the surface.

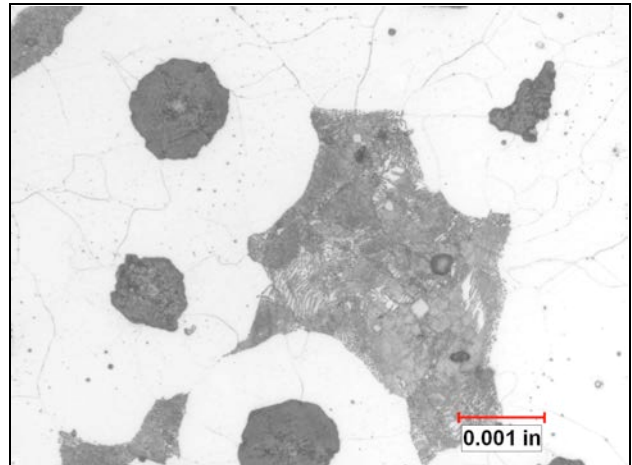
Photo 8: Mag: 500X; Etchant: 3% Nital
Sample #1 – Matrix of ferrite and pearlite, no evidence of carbide or intercellular carbide.
