# *MSi Investigative Summary*

### BACKGROUND

One (1) failed steel bracket assembly for a Hummer vehicle was submitted to our metallurgical testing laboratory for a metal failure analysis investigation. The part reportedly failed at one of the two 90° bends during a fatigue test. It was also reported that an aluminum part to which the bracket had been attached for the duration of the test fractured at the anchoring point. The bracket material processing included hot rolling, pickling and oiling. No further background information was available. We were requested to determine the cause of the bracket assembly failure.

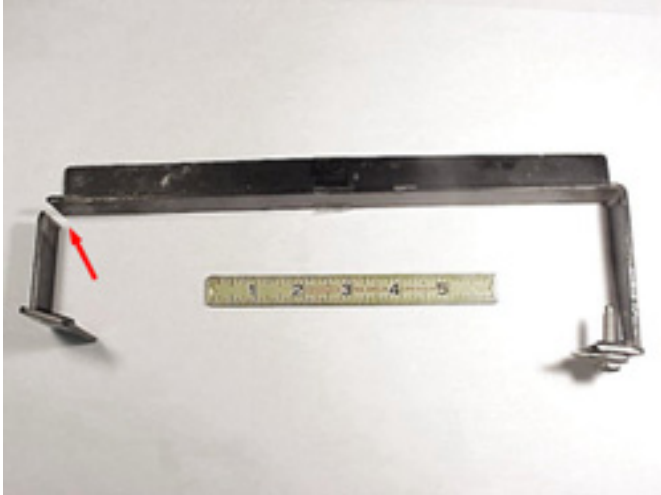
- 1.** Visual and stereoscopic examination of the bracket revealed that the failure occurred at one of the two 90° bends (see Photo 1, arrow).
- 2.** The fracture surface showed two distinct regions. The first region occupied ~90% of the total fracture. It had a thumbnail-like shape, exhibited a relatively flat appearance with evidence of wear damage, and contained semi-circular crack progression lines (beach marks) emerging from a site on the inner surface of the bend. Beach marks are associated with propagation of fatigue cracks under cyclic bending and/or tensile loading. The site of the beach marks emergence was identified as the crack origin. The second region was dark-colored and fibrous, and occupied the remaining ~10% of the surface. Fibrous appearance is commonly associated with

**Photo 1:** Failed bracket, as received

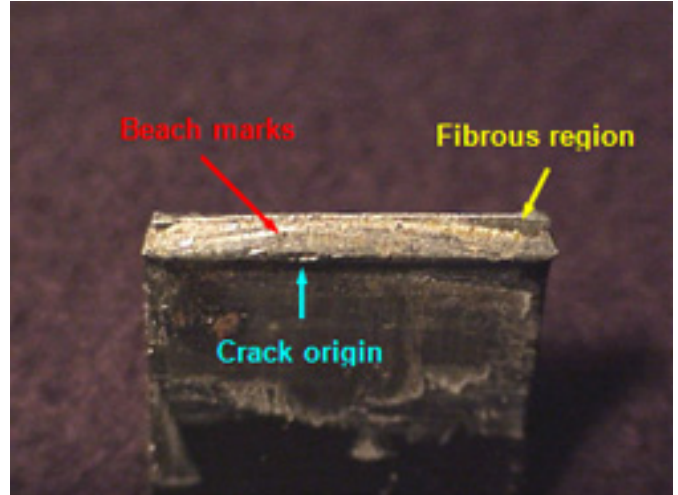
- 1.** Based upon the performed the tests and examinations performed by our metallurgical testing laboratory, it is our opinion that the failure of the submitted steel bracket occurred by reverse bending fatigue failure mechanism followed by a rapid ductile overload fracture. Fatigue cracking initiated inside a 90° bend, where stresses are inherently high.

- 2.** The fatigue cracks propagated under the cyclic test loads through ~90% of the load-bearing cross-section. The final rapid overload fracture occurred through the remaining narrow metal ligament adjacent to the apex of the bend.

ductile overload failures (see Photo 2, arrows).

3. The observed surface features are commonly associated with propagation of fatigue cracks under cyclic bending loading, followed by a rapid ductile overload fracture, when the reduced load-bearing cross-section could not carry the applied stresses.

**Photo 2:** A close-up view of the fracture surface

- 7.** We respectfully recommend reviewing the fatigue test conditions, to identify the likely source of the excessive cyclic loading applied to the submitted bracket.

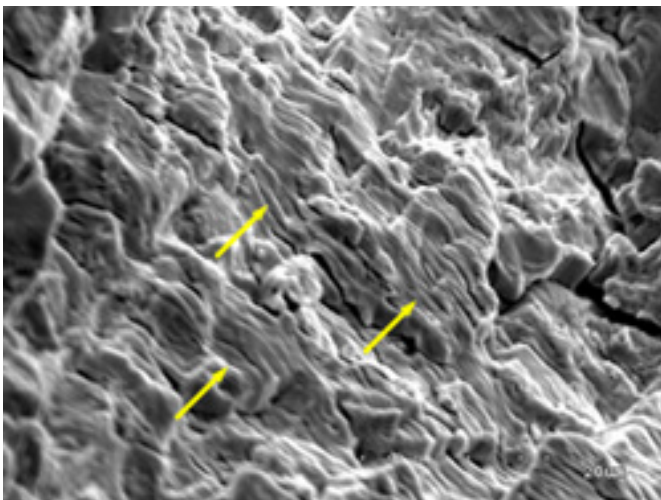
1. An appreciable area on the fracture surface was subjected to extensive post-failure wear damage; however, some better-preserved areas on the fracture were suitable for SEM examination. The examination revealed coarse, evenly-spaced crack progression marks, known as fatigue striations (see Photo 3 on the following page). Such features positively identified the failure mechanism as reversed-bending fatigue.

2. The coarse striation appearance implied a low-cycle, high-stress fatigue mechanism, with the loading stresses extending into the plastic zone of the stress-strain curve. Such striation appearance may be indicative of excessive test loading condition.

**Photo 3:** Magnification: 1,700X SEM view of fatigue striations (arrows) from reverse bending fracture

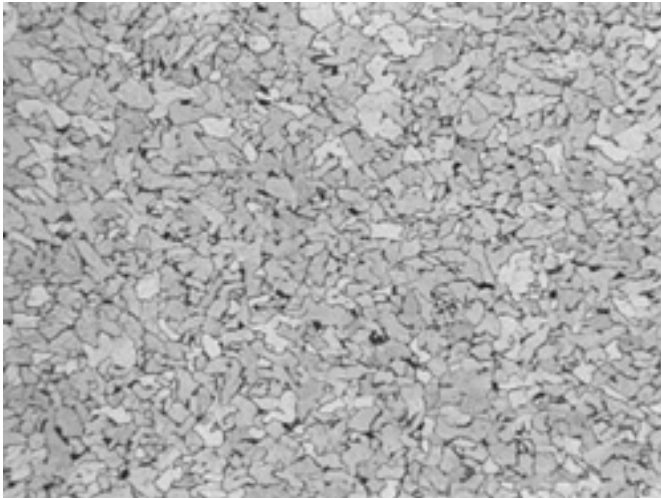
1. Transverse and longitudinal sections removed from the submitted bracket revealed a uniform microstructure consisting of ferrite and pearlite, typical of a hot-rolled ASTM A 1011 carbon steel (see Photos 4 – 5).
2. No evidence was observed of pre-existing steel defects, excessive nonmetallic inclusions, or any other detrimental material conditions that could have contributed to the failure.

**Photo 4:** Mag: 200X: Etchant: 3% Nital Longitudinal cross-section

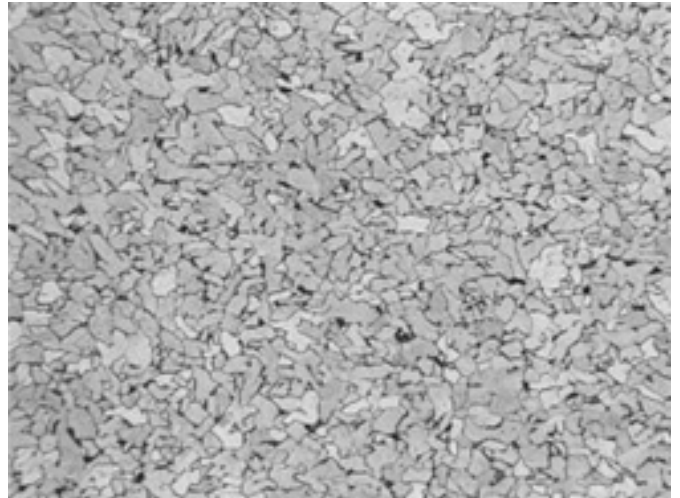
**Photo 5:** Mag: 200X Etchant: 3% Nital Transverse cross-section
