MSi Testing & Engineering, Inc.

MSi Investigative Summary

One (1) metal sample removed from a welded stainless steel pressure vessel was submitted to our laboratory for a metallurgical investigation. Reportedly, the ID surface of the sample exhibited a highly localized corrosion attack. It was also reported that the attack occurred in the form of dark, rounded recesses, and that the affected area was covered by an internal structural component. The ID surface of the sample was partially ground and dye-penetrant tested by maintenance personnel.

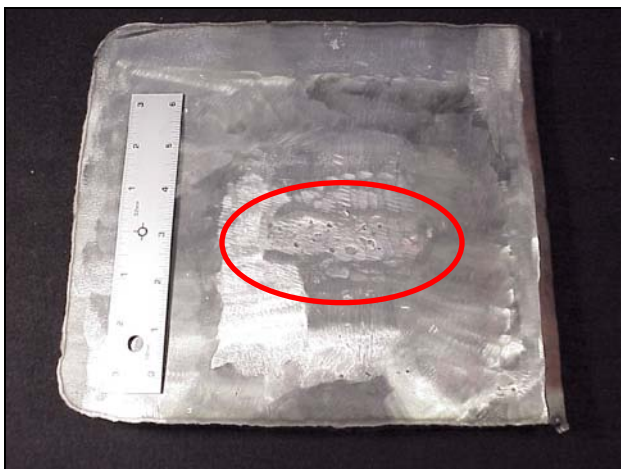
1. Visual and stereoscopic examination of the submitted vessel sample revealed an isle of pitting on the ID surface, with the pits measuring up to 1/4" wide and up to 1/8" deep (see Photos 1 – 2). The area contained evidence of grinding and dye-penetrant testing.

Photo 1: The vessel sample, as received. The pitted area is encircled by the red line.

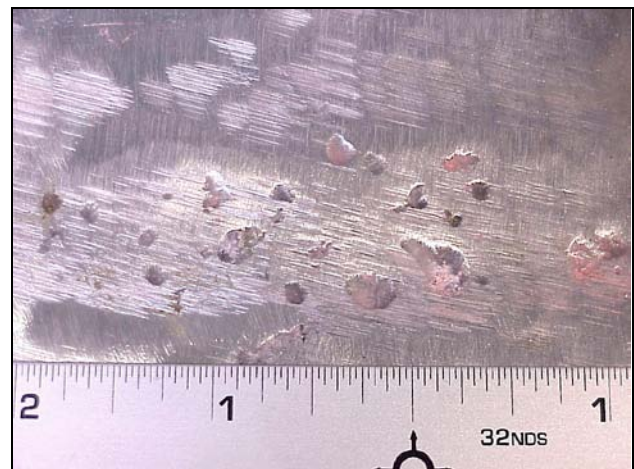
Photo 2: A close-up view of the pitted area.

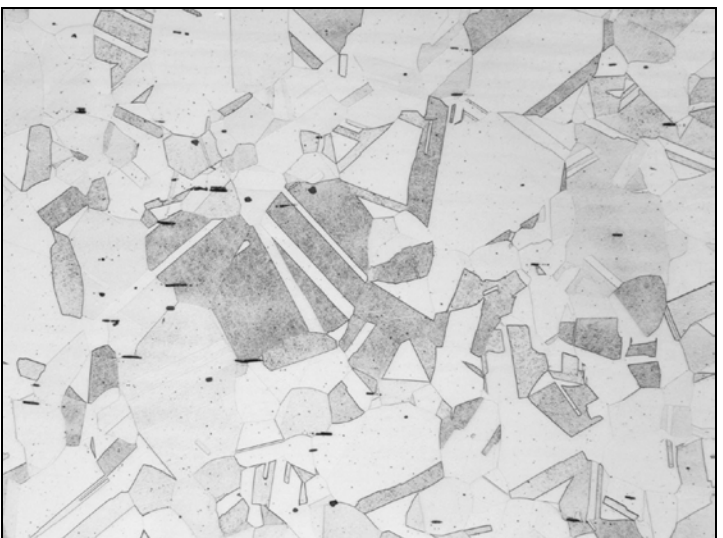
Photo 6: Mag: 100X; Etchant: 10% oxalic acid, electrolytic
A normal austenitic microstructure typical of the base metal.
