# MSi Testing & Engineering, Inc.

## MSi Investigative Summary

Two (2) welded stainless steel tube samples removed from a Bottom Circulation (BC) Heater #1 and identified as “failed” and “intact” were submitted to our laboratory for a metallurgical failure analysis. Reportedly, the failed tube developed cracking after being in service for ~6 months. The intact tube was supplied as a reference. During normal operation the OD surfaces of the tubes had been exposed to saturated steam at ~377°F/190 psia, while the ID surfaces were exposed to a mixture of white and black liquor at ~290°F/280 psia. It was also reported that the BC Heater #1 experienced multiple tube failures, which had occurred roughly at the same location.

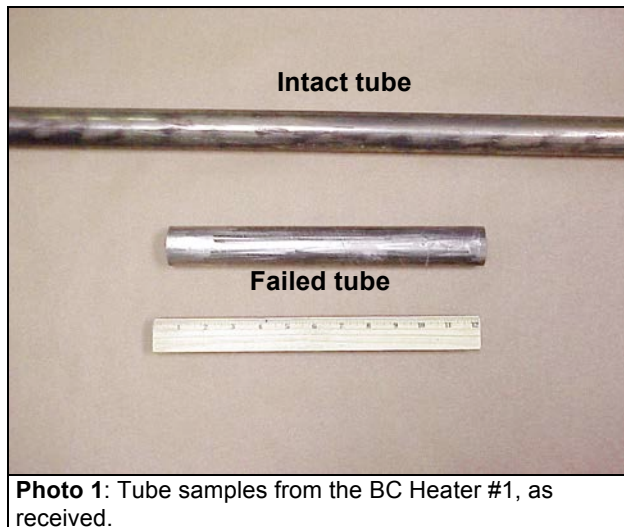
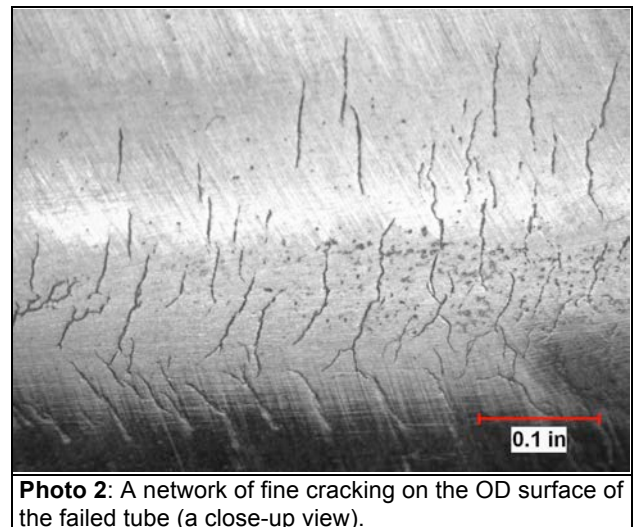
1. Visual and stereoscopic examination of the tubing samples from the BC Heater #1 revealed dark-gray discoloration on the intact tube and evidence of surface polishing on the failed tube (see Photo 1).
2. When viewed at a higher magnification, the OD surface on the failed tube exhibited a network of transverse and oblique cracking (see Photo 2).
3. The failed tube sample was used for metallographic examination, chemical analysis and hardness testing, described in the following sections of this report.
4. The intact tube sample was reserved for mechanical testing described in the following sections of this report.

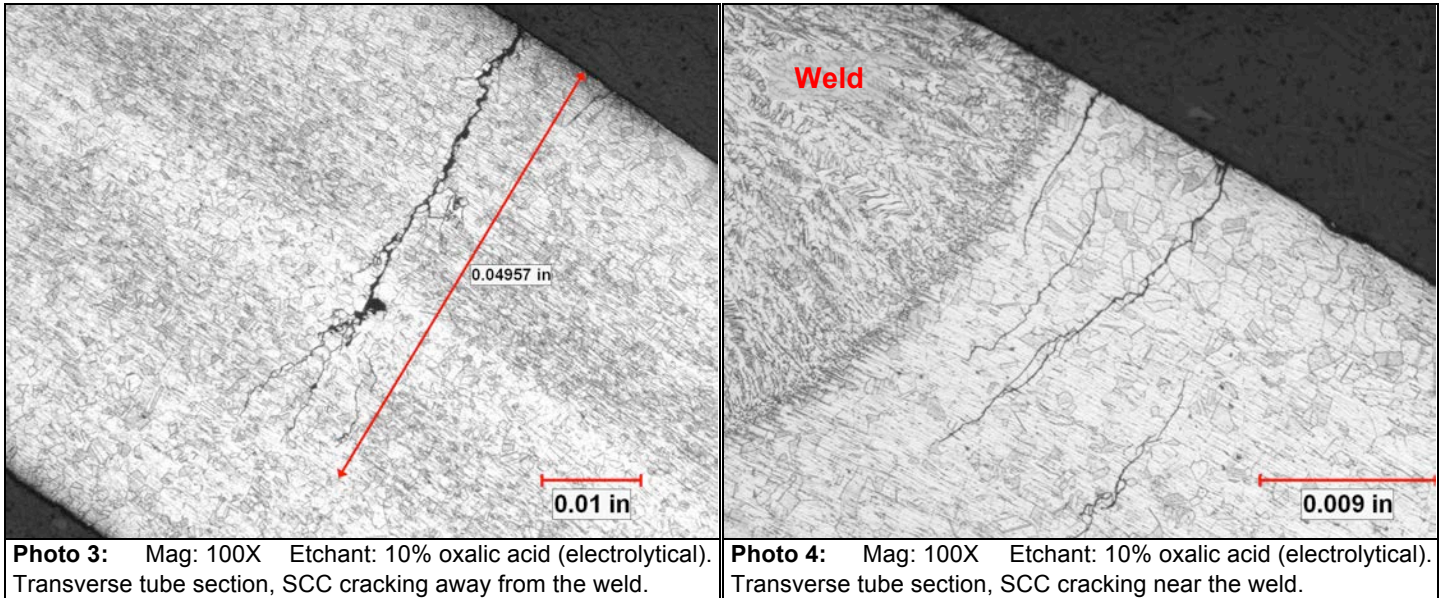
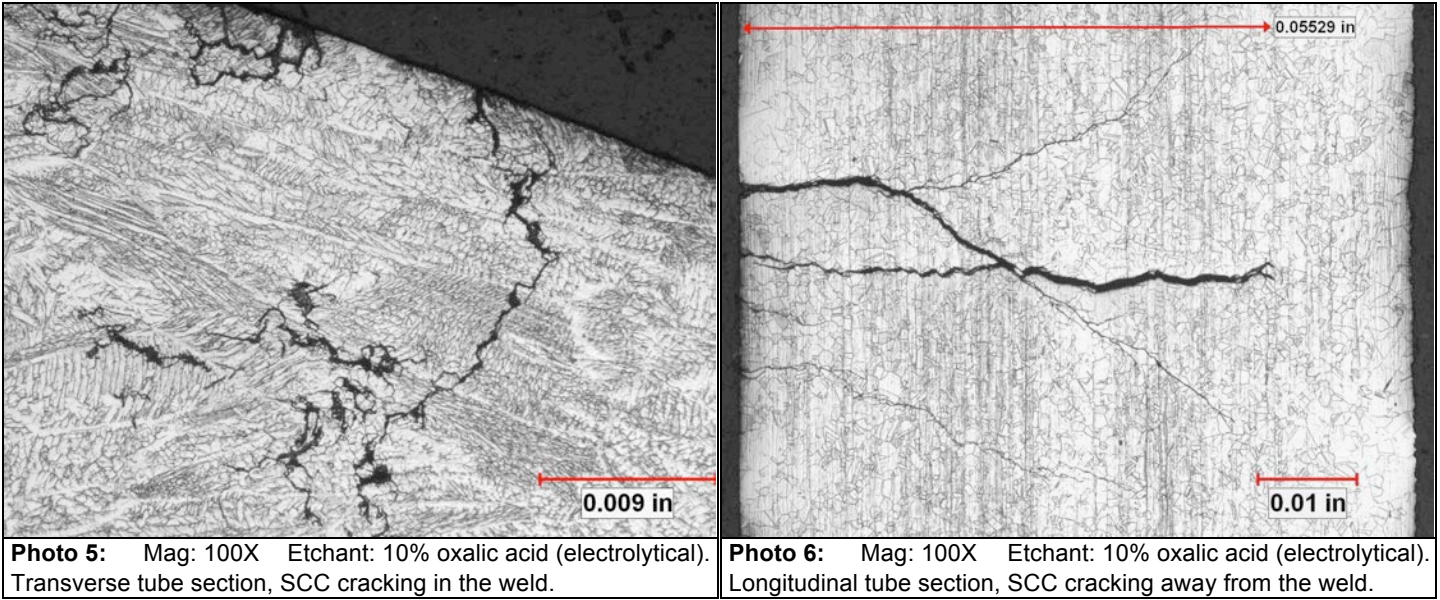
1. Transverse and longitudinal sections removed from the failed tube revealed multiple branching cracks propagating from the OD surface (see Photos 3 – 6 on the following page). Through-wall crack propagation in the examined areas was estimated at ~85%.
2. The mode of cracking was identified primarily as transgranular with occasional evidence

of intergranular propagation. The cracks appeared to be uniformly distributed throughout the welded areas and the areas away from the weld. The observed cracking morphology is characteristic of a stress-corrosion cracking (SCC) attack in 300-series stainless steel.

3. SCC failures in 300-series stainless steels occur under exposure to chlorides, bleach or hydrated liquor salts. Identification of the corrosive species directly responsible for the attack could not be performed, since the OD surface of the affected tube had been mechanically polished by maintenance personnel.

- 4. The tubing material revealed a normal equiaxed austenitic microstructure typical of Type 304/304L stainless steel in an annealed condition. The metal showed no evidence of sensitization, pre-existing steel defects, excessive nonmetallic inclusions, or any other detrimental material conditions that could have contributed to the failure.

8. To prevent similar future BC heater tubing failures, we respectfully recommend that service exposure of the 300-series stainless steel tubes to chlorides, bleach or hydrated liquor salts be avoided. Another alternative is to review and improve the baffling of the tube bundle. If service conditions would require continual or intermittent exposure of the tubing to a corrodent-bearing environment, then an upgrade to a more SCC-resistant material may be warranted. The examples include, but are not limited to, ferritic stainless steels 29-4C and Sea-Cure. Duplex stainless steels with 10-28% Cr and 4-8% Ni can also be taken into consideration as alternative materials. Although duplex stainless steels are susceptible to chloride-induced SCC, the stress level that triggers the attack in duplex steels is generally much higher than that for austenitic stainless steels. **Note:** *any design changes (including material upgrades) must be approved by the original equipment manufacturer.*
