# MSi Testing & Engineering, Inc.

## Background

Our Weld Testing Laboratory was requested to perform Charpy V-Notch Impact Testing, Corrosion Testing, Weld Ferrite Determination, Weld Microexamination and Vickers microhardness testing to document any evidence of detrimental weld related conditions.

ID	Size	Material	Specification
2209-2	¼" Plate	Duplex Stainless	API 938-C

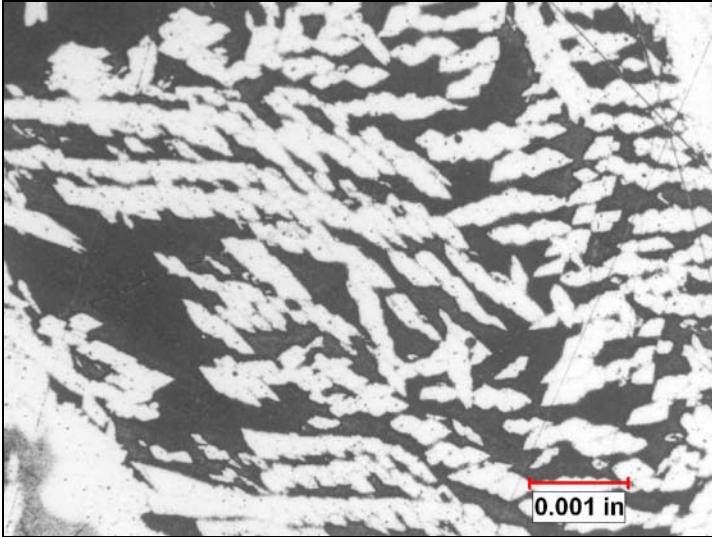
**Photo 1:** Mag: 500X; Etchant: Beraha Reagent  
Location: Weld at Cap

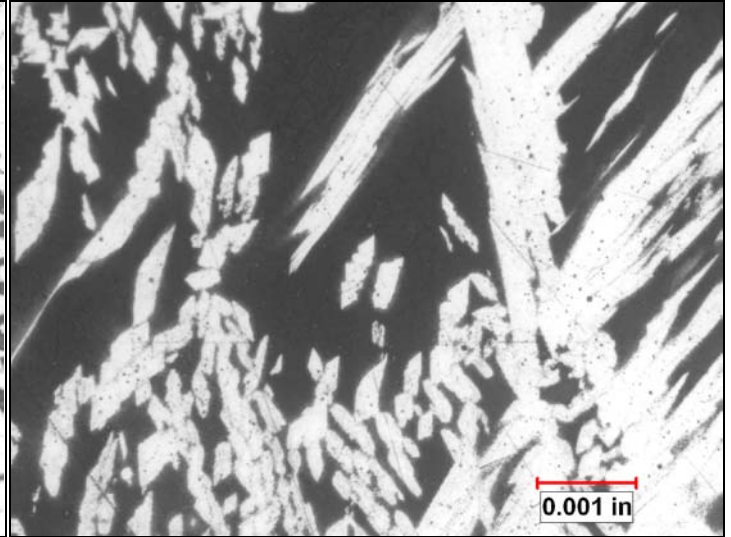
**Photo 2:** Mag: 500X; Etchant: Beraha Reagent  
Location: Weld at Mid-Thickness

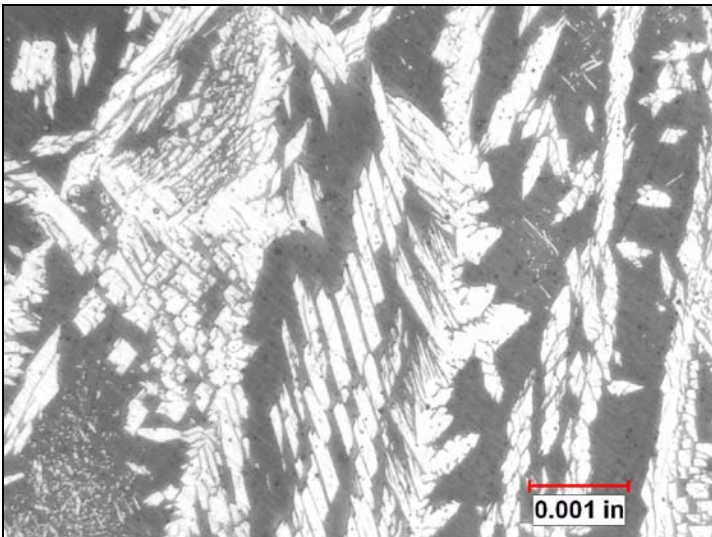
**Photo 3:** Mag: 500X; Etchant: Beraha Reagent  
Location: Weld at Root

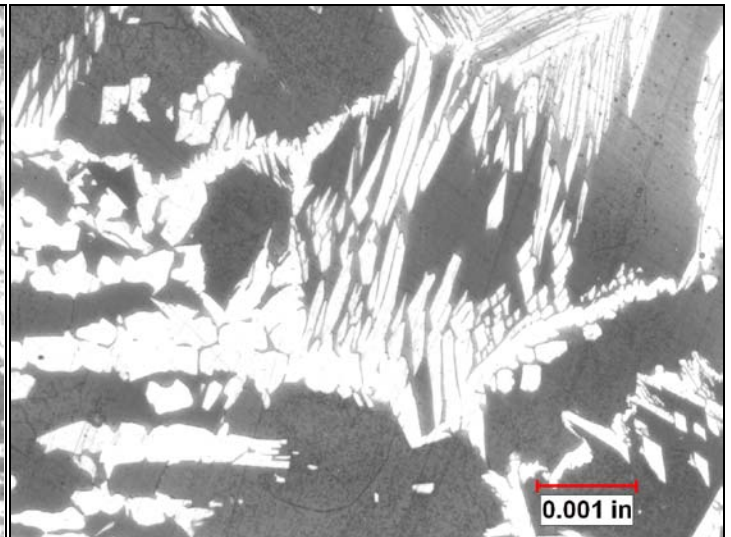
**Photo 4:** Mag: 500X; Etchant: Beraha Reagent  
Location: HAZ of Base A at Root

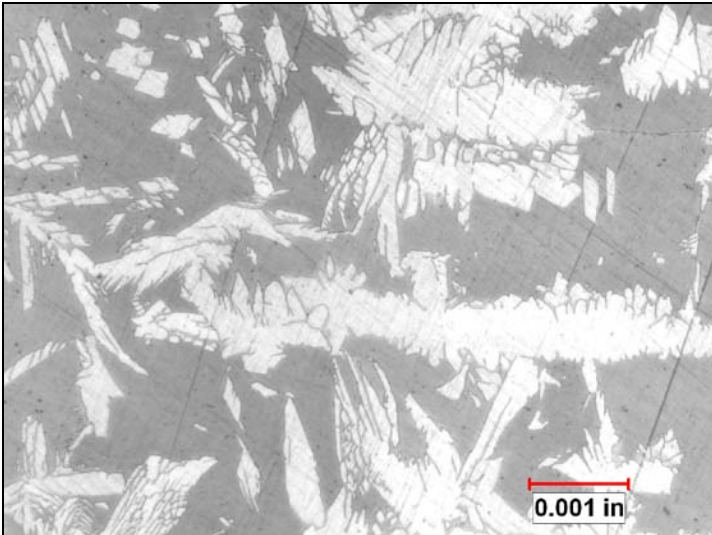
**Photo 5:** Mag: 500X; Etchant: Beraha Reagent  
Location: HAZ of Base B at Root

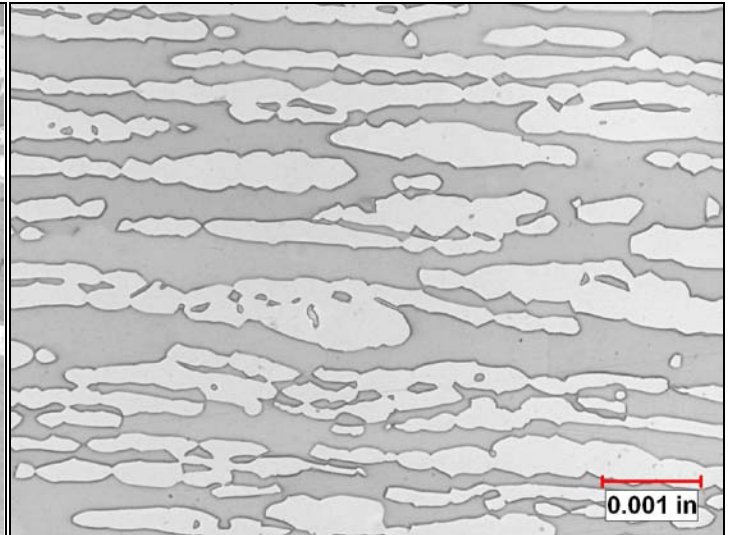
**Photo 6:** Mag: 500X; Etchant: Electrolytic NaOH  
Location: Base A at Mid-Thickness

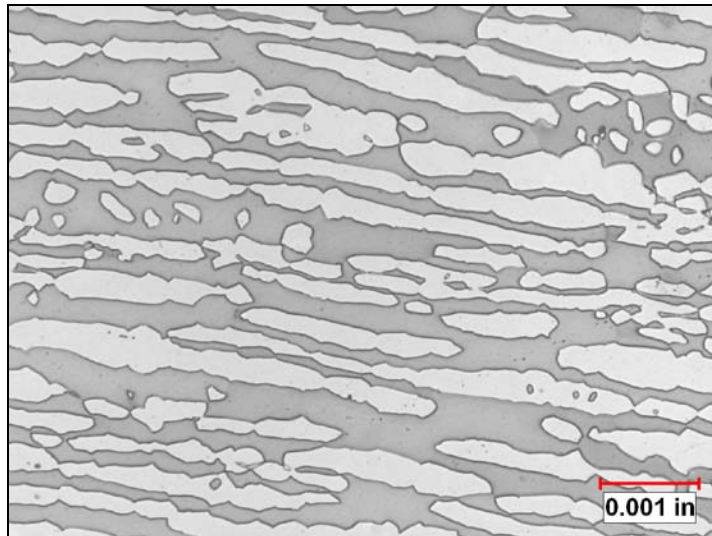
**Photo 7:** Mag: 500X; Etchant: Electrolytic NaOH  
Location: Base B at Mid-Thickness

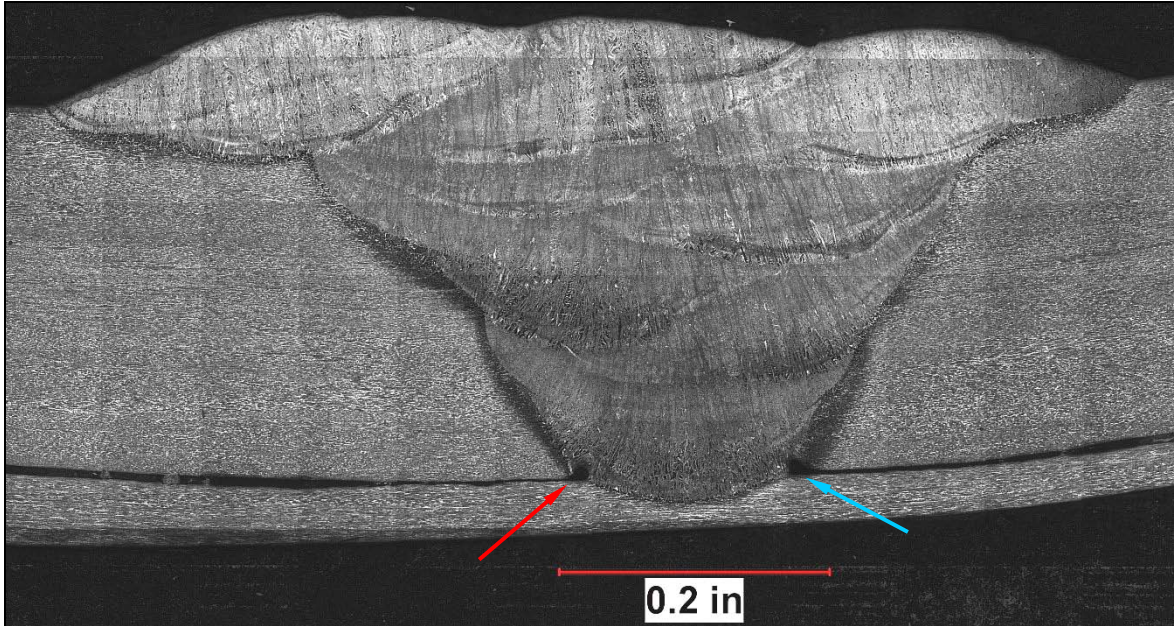
The macro-examination revealed complete fusion between the weld and the base metal as well as between individual weld passes, however weld slag inclusions and a weld underfill condition was observed on both sides of the weld root (see Photos 8 - 10).

**Photo 8:** Weld profile

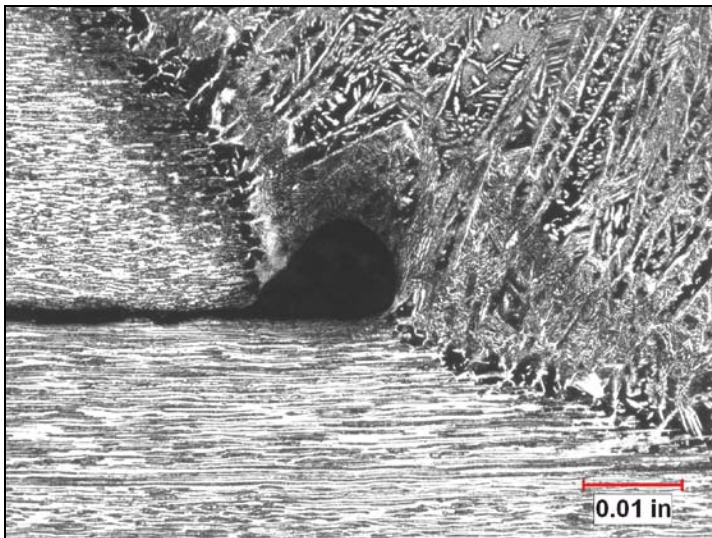
**Photo 9:** Mag: 50X; Etchant: Hot HCl solution  
Weld underfill condition (denoted with red arrow on Photo 8)

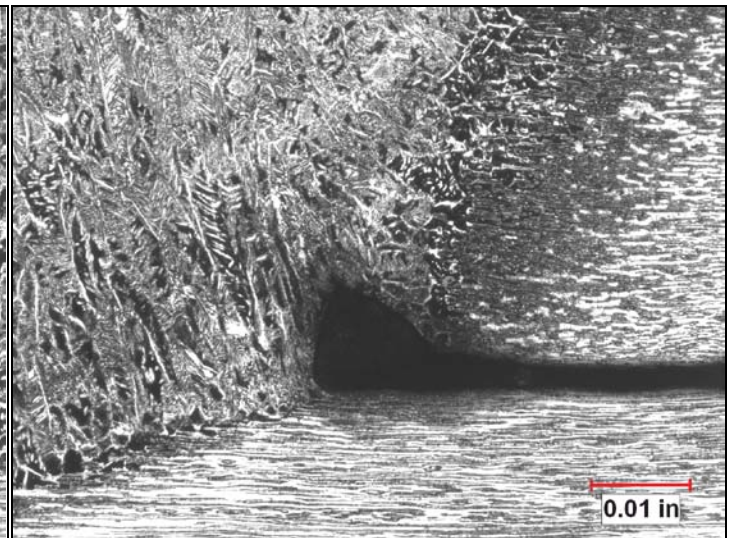
**Photo 10:** Mag: 50X; Etchant: Hot HCl solution  
Weld underfill condition (denoted with blue arrow on Photo 8)
